Florida Department of State
Division of Historical Resources

**HISTORIC JEFFERSON
COUNTY HIGH SCHOOL
RESTORATION**

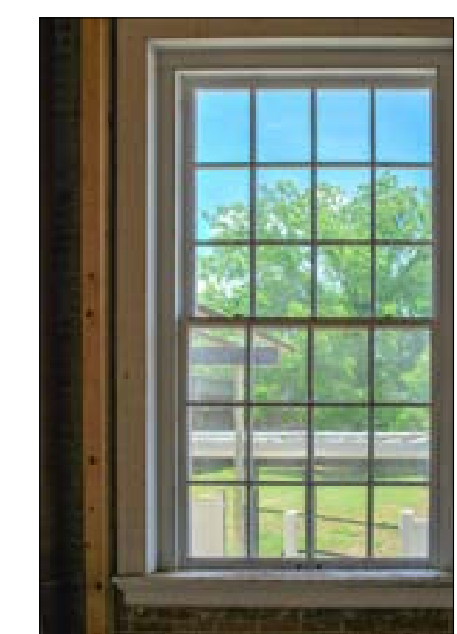
2 WINDOW NO. 007C
ROOM 007

- NOTES
- EXISTING WOOD FRAME, SILL, HARDWARE, ETC. COMPONENTS ARE IN GOOD TO FAIR CONDITION AND GENERALLY SUITED FOR RESTORATION REUSE UNLESS NOTED OTHERWISE.

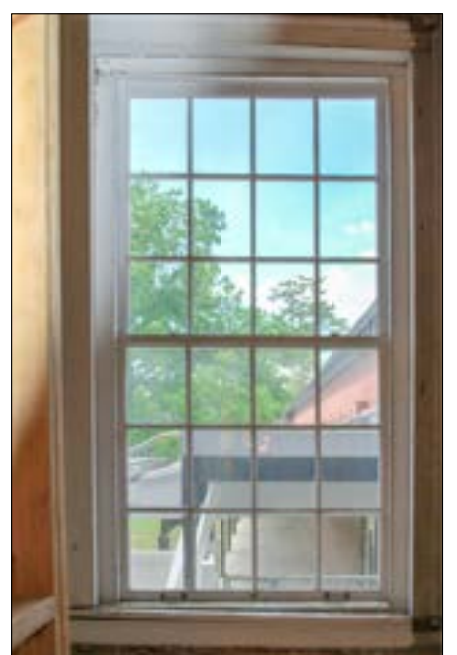
1 WINDOW NO. 007B
ROOM 007

- NOTES
- EXISTING WOOD FRAME, SILL, HARDWARE, ETC. COMPONENTS ARE IN GOOD TO FAIR CONDITION AND GENERALLY SUITED FOR RESTORATION REUSE UNLESS NOTED OTHERWISE.
 - RESTORE EXISTING SILL TO PREVENT OPENING TO EXTERIOR

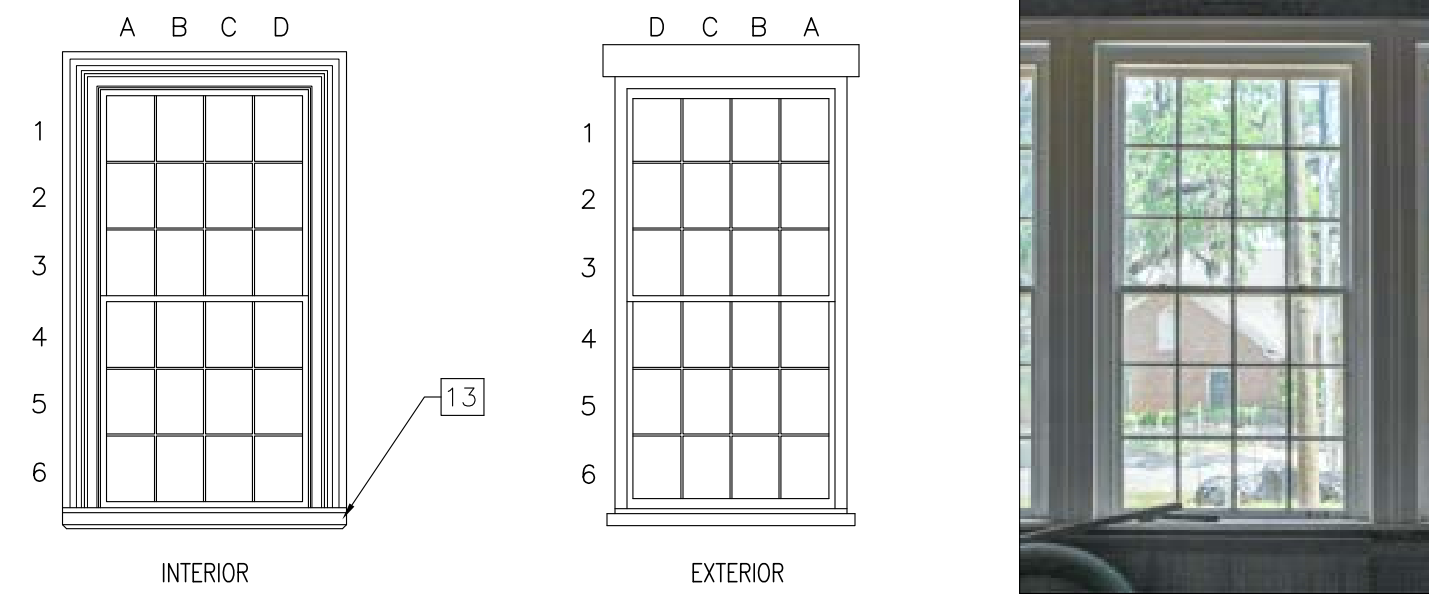
1 WINDOW NO. 105B
ROOM 105

1. EXISTING WOOD WINDOW SASH, SILL, CASING, ETC. COMPONENTS ARE IN GOOD TO FAIR CONDITION AND GENERALLY SUITED FOR RESTORATION AND REUSE UNLESS NOTED OTHERWISE.
2. REPLACE MISSING APRON, UNLESS WAINSCOTING TO BE INSTALLED IN ITS PLACE.

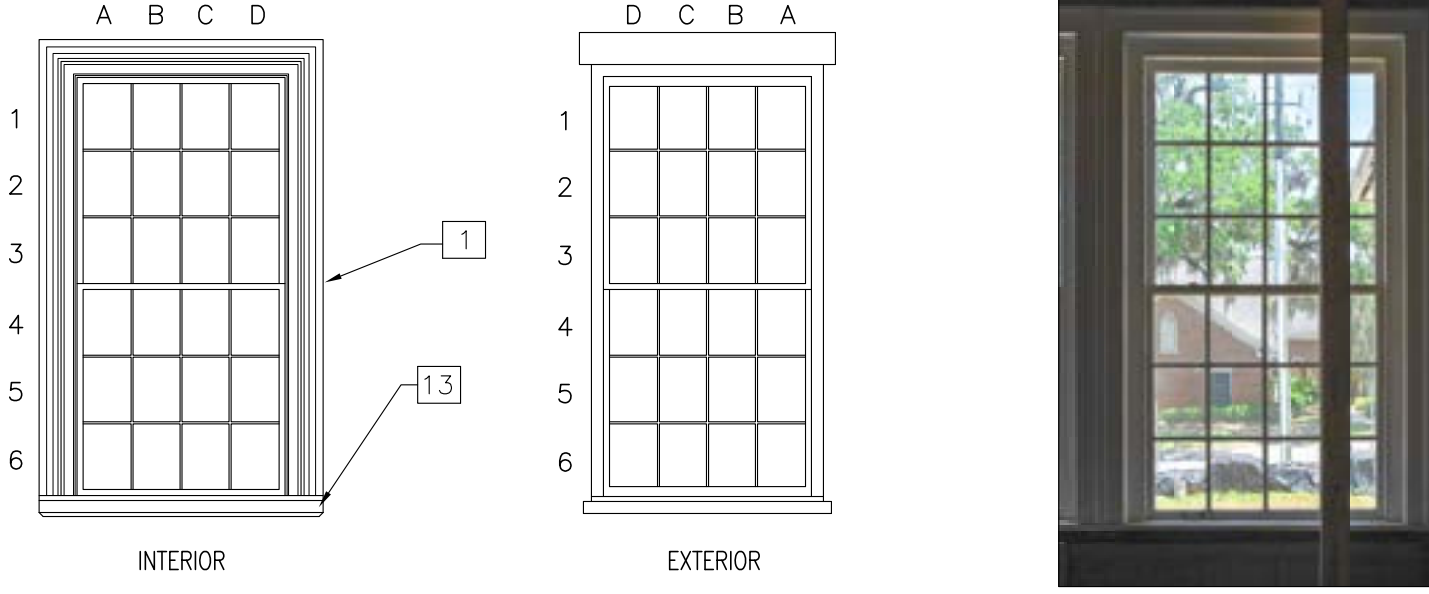
2 WINDOW NO. 105C
ROOM 105

1. EXISTING WOOD WINDOW SASH, SILL, CASING, ETC. COMPONENTS ARE IN GOOD TO FAIR CONDITION AND GENERALLY SUITED FOR RESTORATION AND REUSE UNLESS NOTED OTHERWISE.
2. REPLACE MISSING APRON, UNLESS WAINSCOTING TO BE INSTALLED IN ITS PLACE.

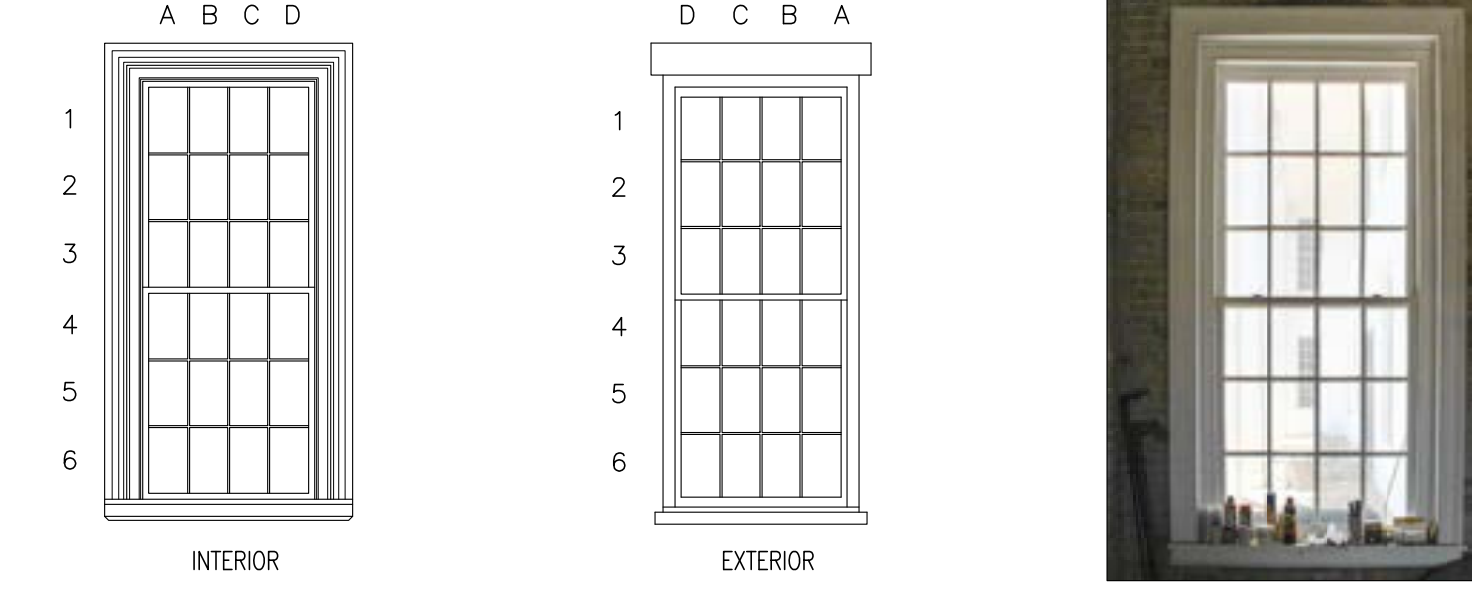
3 WINDOW NO. 106A
ROOM 106

1. EXISTING WOOD WINDOW SASH, SILL, CASING, ETC. COMPONENTS ARE IN GOOD TO FAIR CONDITION AND GENERALLY SUITED FOR RESTORATION AND REUSE UNLESS NOTED OTHERWISE.

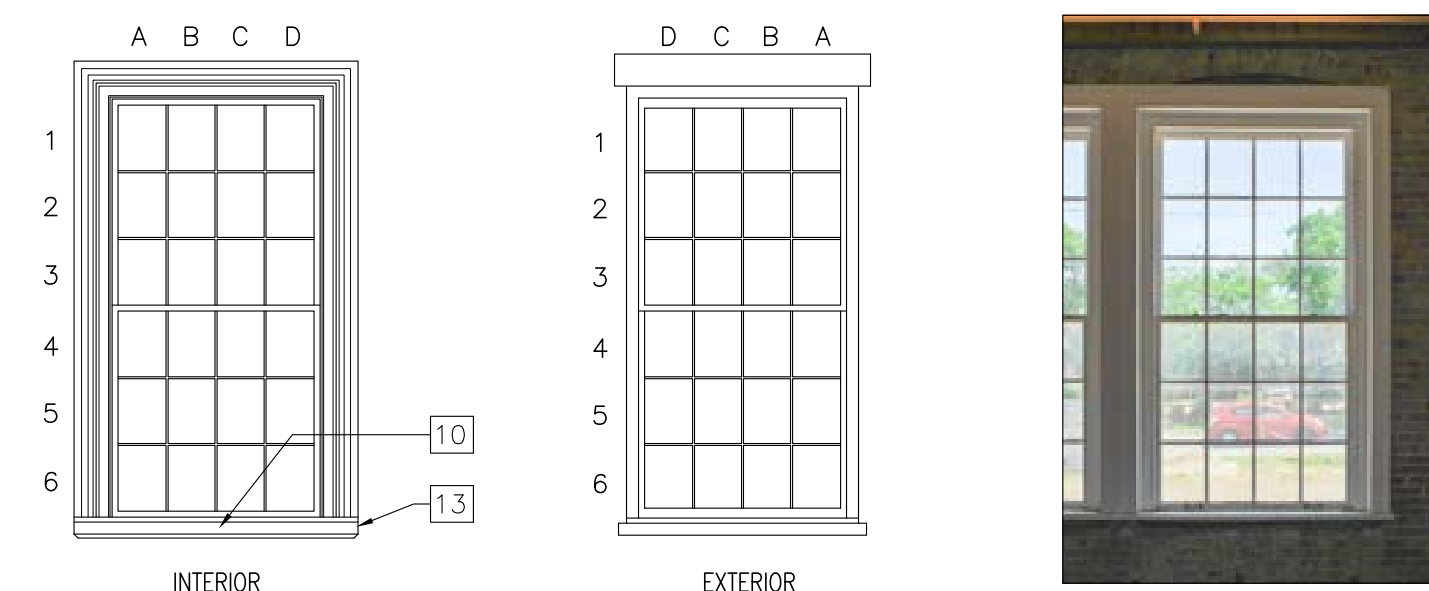
4 WINDOW NO. 106B
ROOM 106

1. EXISTING WOOD WINDOW SASH, SILL, CASING, ETC. COMPONENTS ARE IN GOOD TO FAIR CONDITION AND GENERALLY SUITED FOR RESTORATION AND REUSE UNLESS NOTED OTHERWISE.
2. REPLACE MISSING APRON, UNLESS WAINSCOTING TO BE INSTALLED IN ITS PLACE.
3. REPLACE ROTTEN WOOD BASE FRAMING (SEE GENERAL NOTES)

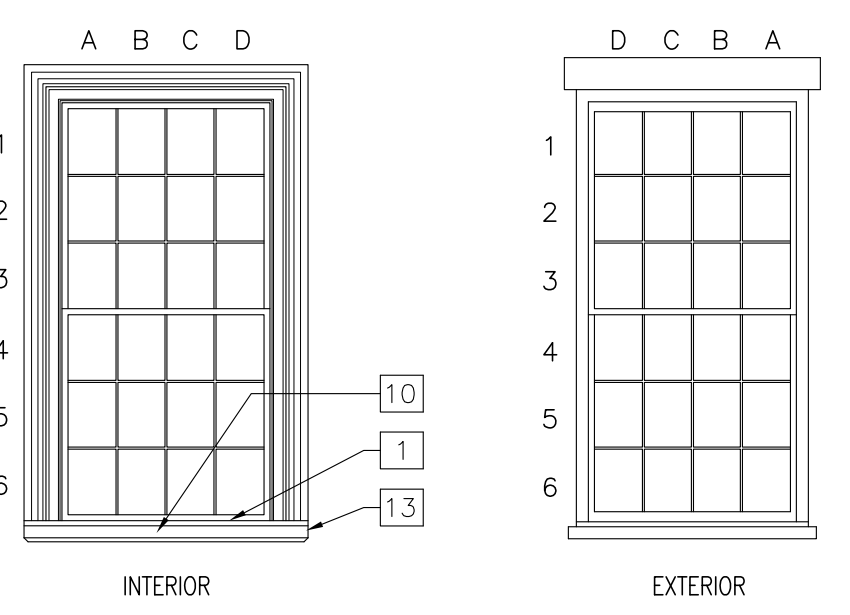
2 WINDOW NO. 107A
ROOM 107

- EXISTING WOOD WINDOW SASH, SILL, CASING, ETC. COMPONENTS ARE IN GOOD TO FAIR CONDITION AND GENERALLY SUITED FOR RESTORATION AND REUSE UNLESS NOTED OTHERWISE.
- REPLACE MISSING APRON, UNLESS WAINSCOTING TO BE INSTALLED IN ITS PLACE.
- REPLACE WOOD ROT AT BASE FRAMING (SEE GENERAL NOTES)
- REPAIR AND FIX HOLES IN RAIL AND STILE AT HEAD

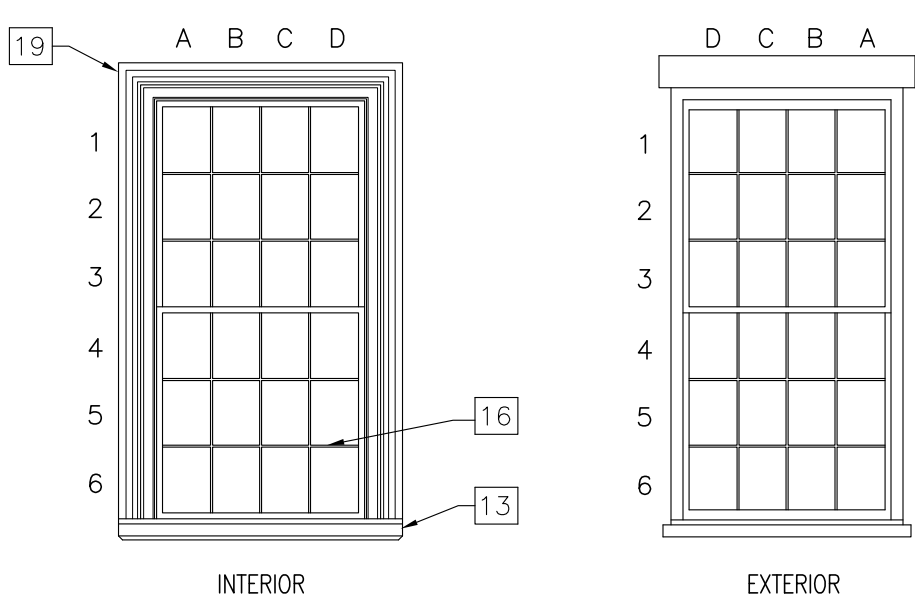
3 WINDOW NO. 108A
ROOM 108

- EXISTING WOOD WINDOW SASH, SILL, CASING, ETC. COMPONENTS ARE IN GOOD TO FAIR CONDITION AND GENERALLY SUITED FOR RESTORATION AND REUSE UNLESS NOTED OTHERWISE.
- REPLACE MISSING APRON, UNLESS WAINSCOTING TO BE INSTALLED IN ITS PLACE.

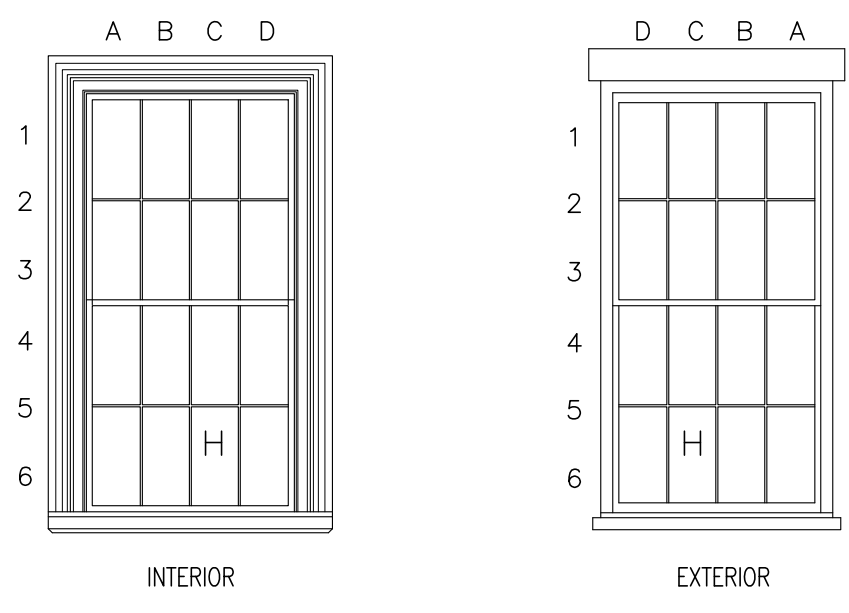
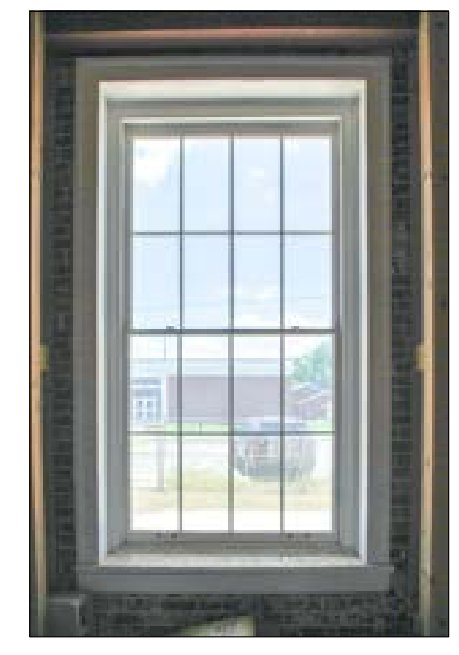
4 WINDOW NO. 111A
ROOM 111

- EXISTING WOOD WINDOW SASH, SILL, CASING, ETC. COMPONENTS ARE IN GOOD TO FAIR CONDITION AND GENERALLY SUITED FOR RESTORATION AND REUSE UNLESS NOTED OTHERWISE.
- REMOVE CRACKED HISTORIC GLASS TO POSSIBLY BE USED IN SMALLER OPENING (SEE GENERAL NOTES)

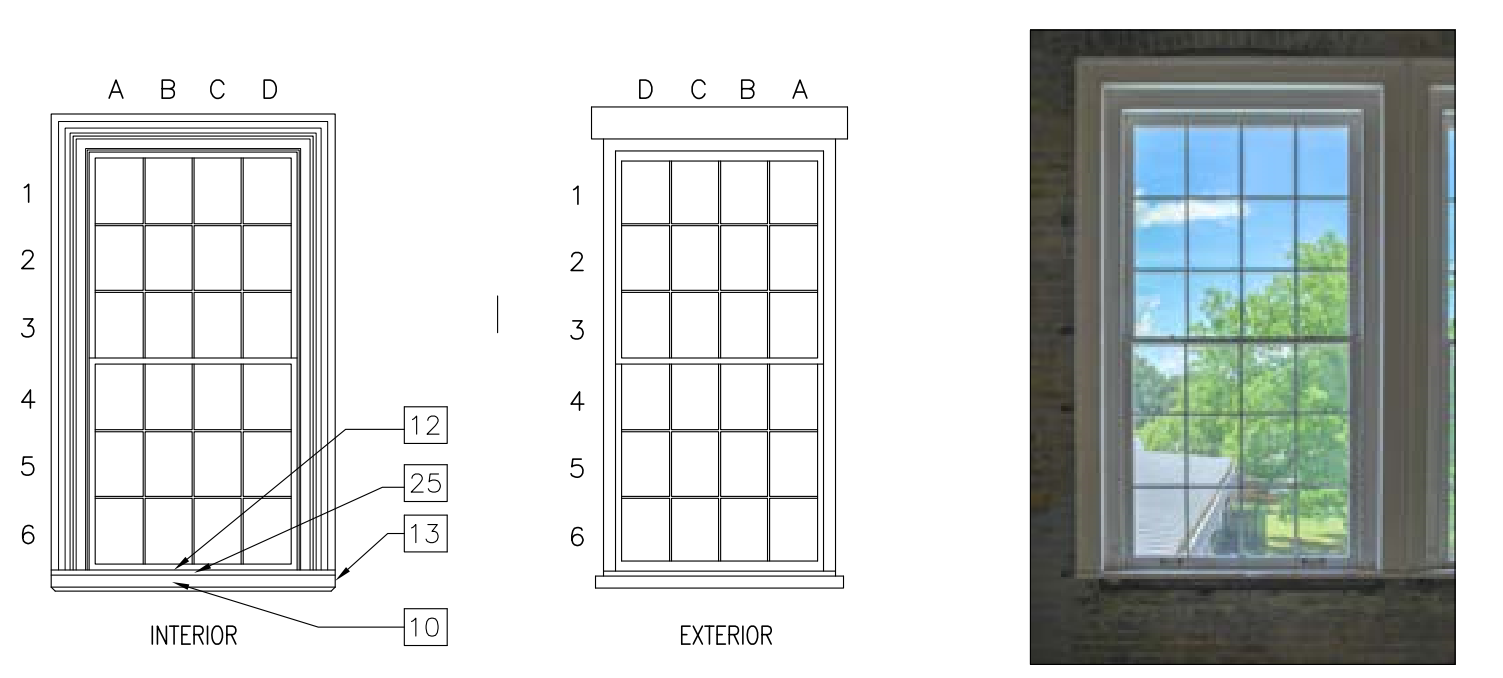
2 WINDOW NO. 206C
ROOM 206

NOTES
1. EXISTING WOOD WINDOW SASH, SILL, CASING, ETC. COMPONENTS ARE IN GOOD TO FAIR CONDITION AND GENERALLY SUITED FOR RESTORATION AND REUSE UNLESS NOTED OTHERWISE.
2. REPLACE MISSING APRON, UNLESS WAINSCOTING TO BE INSTALLED IN ITS PLACE.
3. REPLACE ROTTEN WOOD BASE FRAMING (SEE GENERAL NOTES)

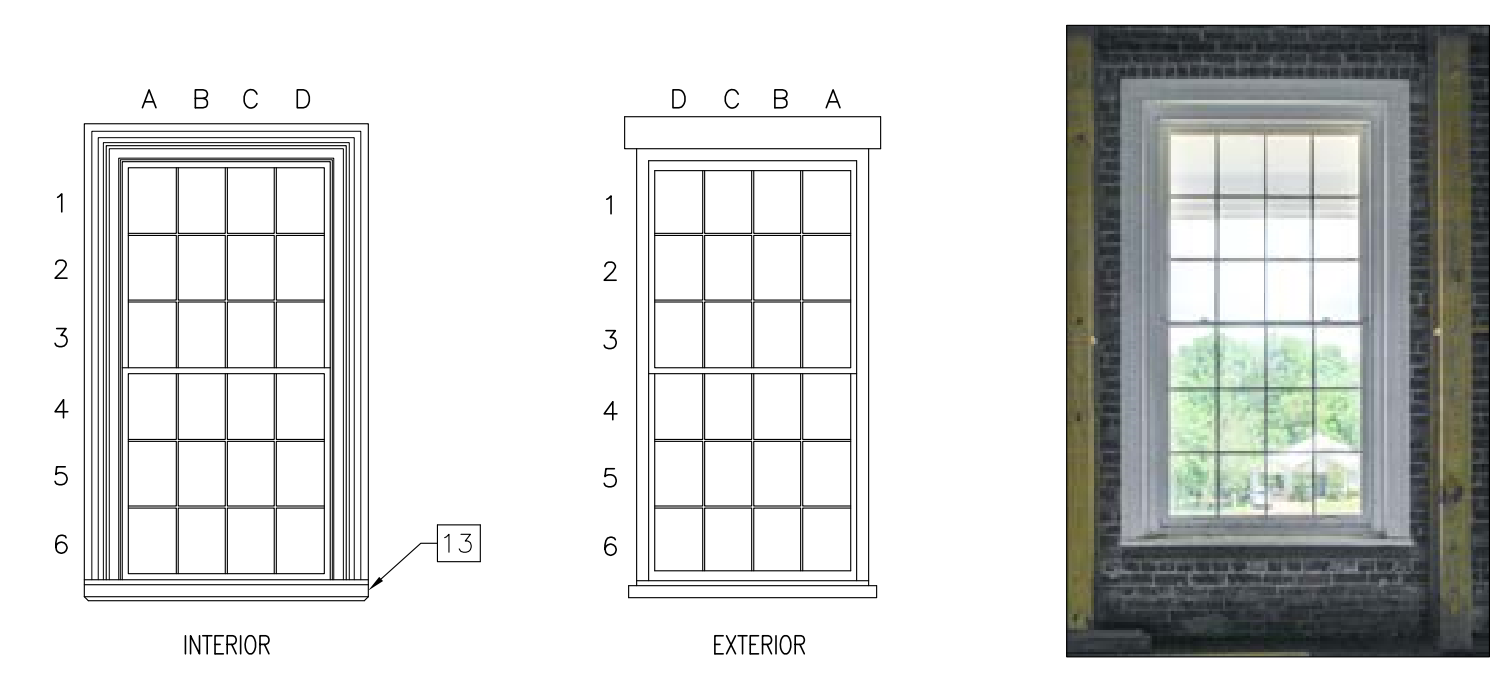
5 WINDOW NO. 207C
ROOM 207

NOTES
1. EXISTING WOOD WINDOW SASH, SILL, CASING, ETC. COMPONENTS ARE IN GOOD TO FAIR CONDITION AND GENERALLY SUITED FOR RESTORATION AND REUSE UNLESS NOTED OTHERWISE.
2. REPLACE MISSING APRON, UNLESS WAINSCOTING TO BE INSTALLED IN ITS PLACE.

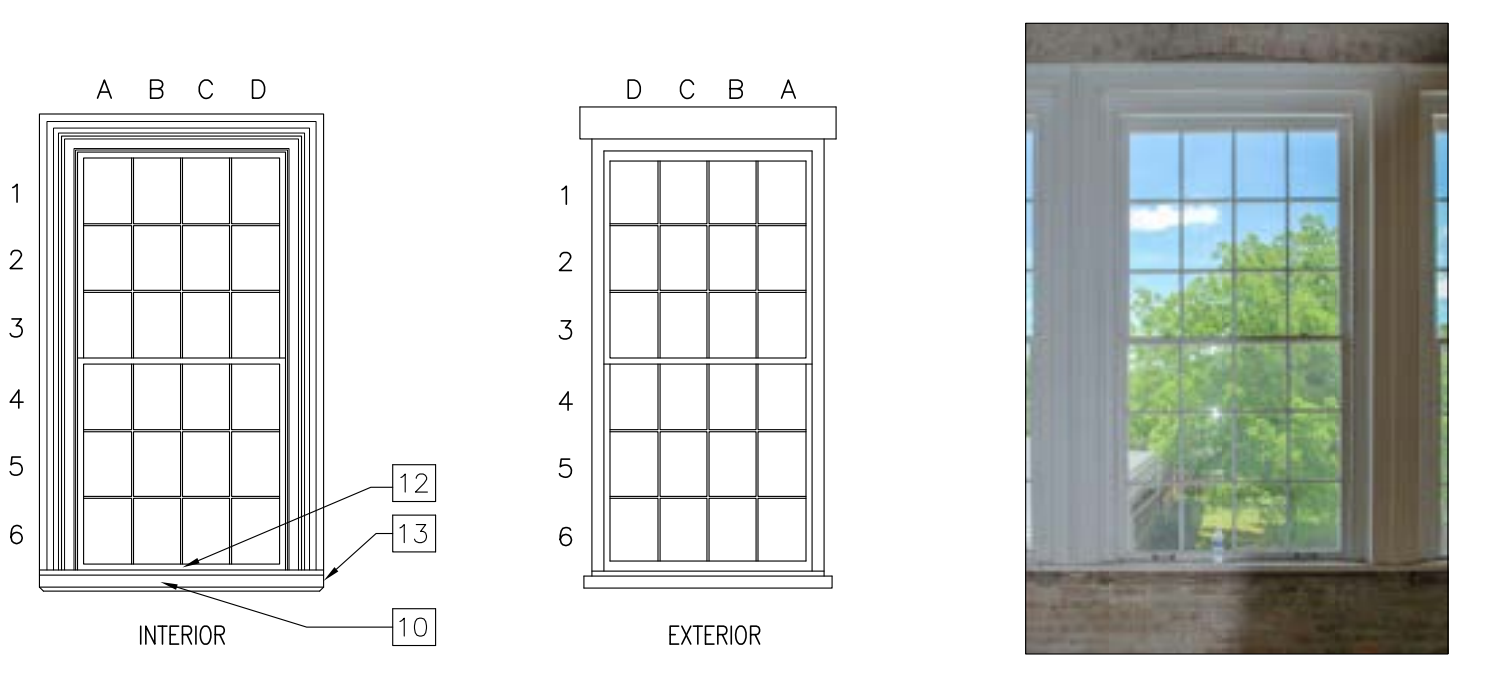
1 WINDOW NO. 206B
ROOM 206

NOTES
1. EXISTING WOOD WINDOW SASH, SILL, CASING, ETC. COMPONENTS ARE IN GOOD TO FAIR CONDITION AND GENERALLY SUITED FOR RESTORATION AND REUSE UNLESS NOTED OTHERWISE.
2. REPLACE MISSING APRON, UNLESS WAINSCOTING TO BE INSTALLED IN ITS PLACE.
3. REPLACE ROTTEN WOOD BASE FRAMING (SEE GENERAL NOTES)

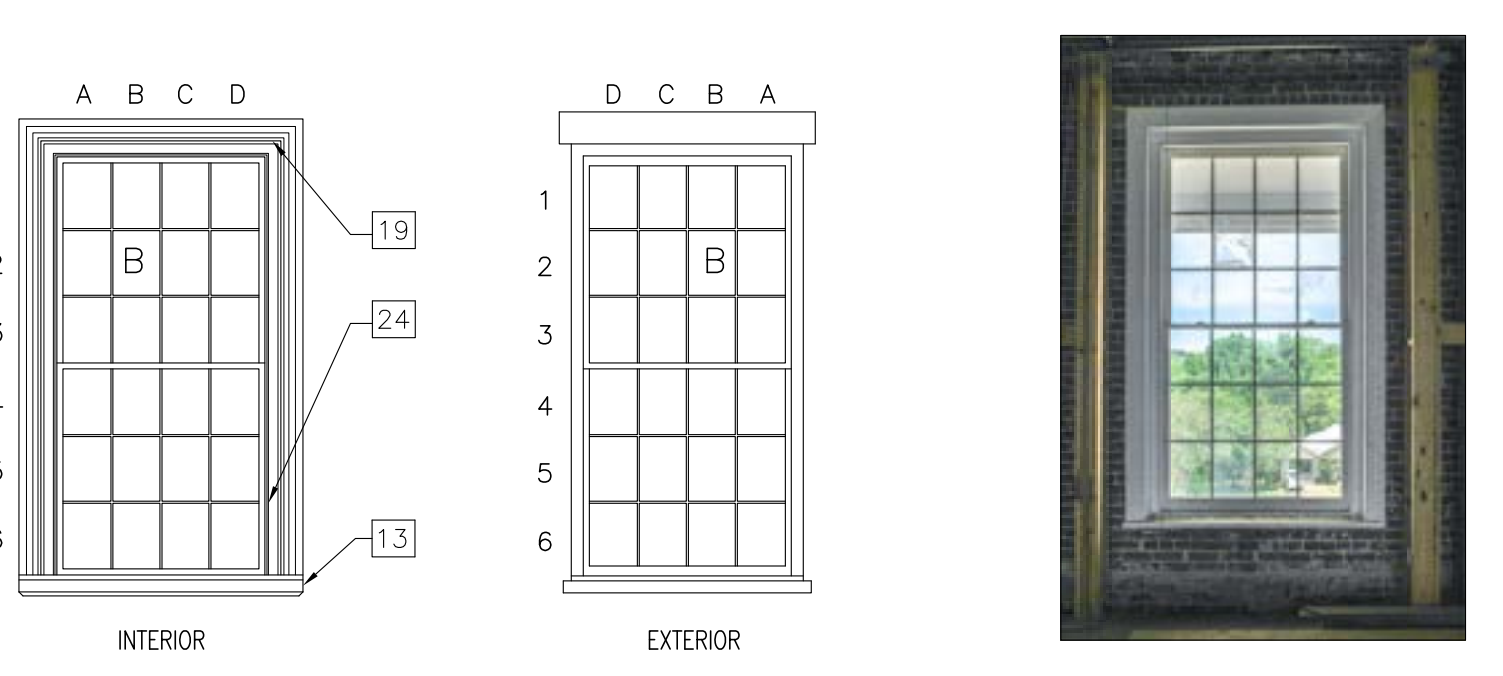
4 WINDOW NO. 207B
ROOM 207

NOTES
1. EXISTING WOOD WINDOW SASH, SILL, CASING, ETC. COMPONENTS ARE IN GOOD TO FAIR CONDITION AND GENERALLY SUITED FOR RESTORATION AND REUSE UNLESS NOTED OTHERWISE.
2. REPLACE MISSING APRON, UNLESS WAINSCOTING TO BE INSTALLED IN ITS PLACE.
