Florida Department of State
Division of Historical Resources

**HISTORIC JEFFERSON
COUNTY HIGH SCHOOL
RESTORATION**

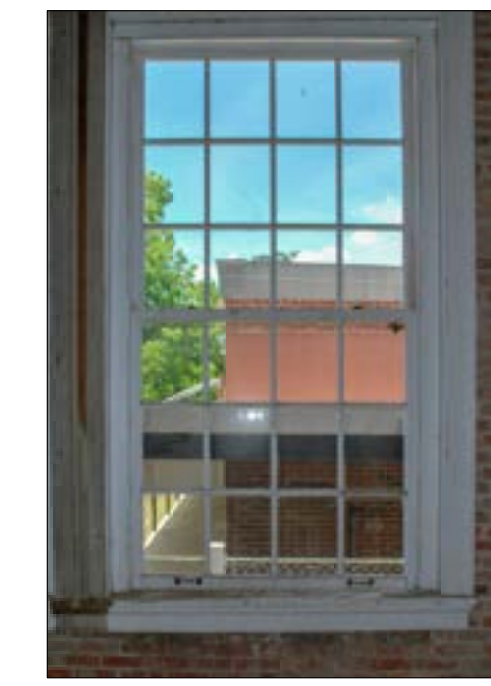
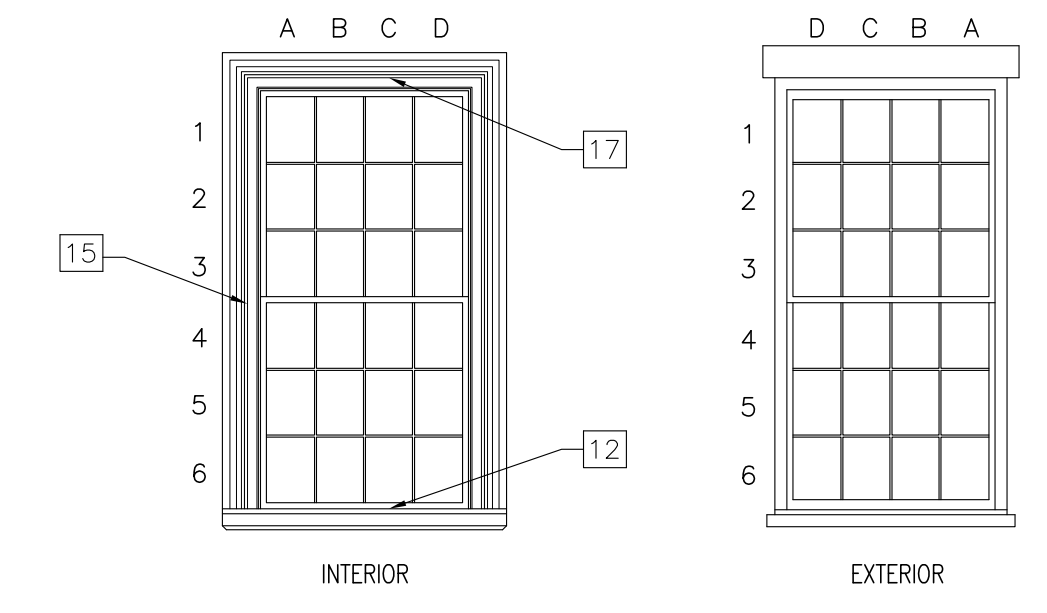
IMAGE_101A

- NOTES
- EXISTING WOOD WINDOW SASH, SILL, ETC. COMPONENTS ARE IN GOOD TO FAIR CONDITION AND GENERALLY SUITED FOR RESTORATION AND REUSE UNLESS NOTED OTHERWISE.
 - REPLACE ENTIRE HEAD CASING TO MATCH EXISTING

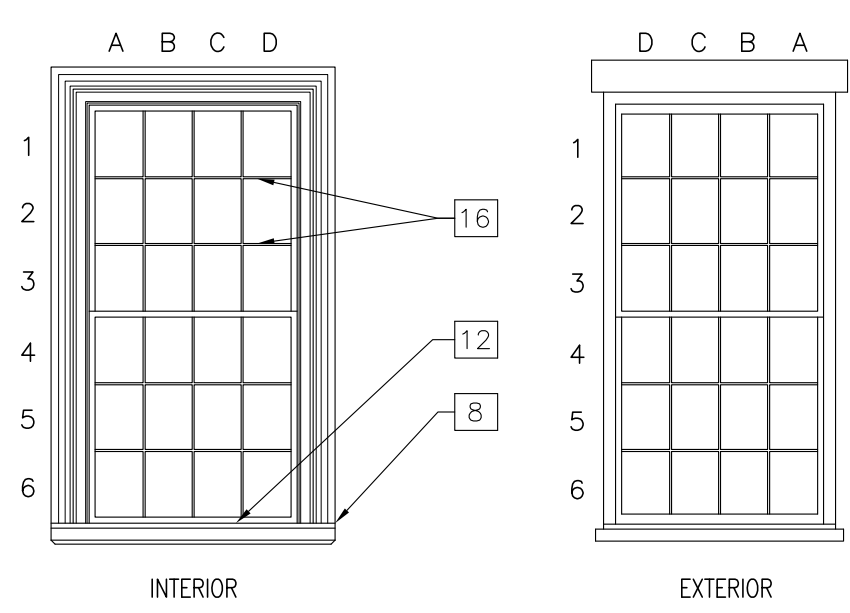
5 WINDOW NO. 101C
ROOM 101

- NOTES
- EXISTING WOOD WINDOW SASH, SILL, CASING, ETC. COMPONENTS ARE IN GOOD TO FAIR CONDITION AND GENERALLY SUITED FOR RESTORATION AND REUSE UNLESS NOTED OTHERWISE
 - INSPECT SILL AND JAMB FOR WATER DAMAGE. CONFIRM CONDITION REPAIR/REPLACE BASED ON CONDITION.

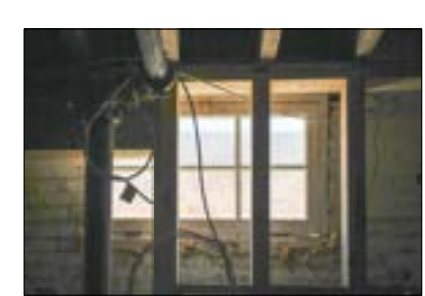
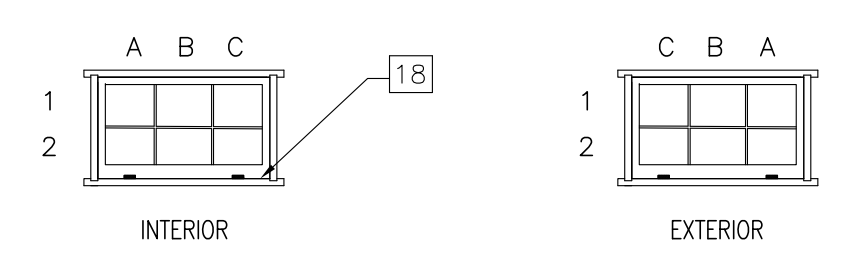
IMAGE_007B

- NOTES
- EXISTING WOOD FRAME, SILL, HARDWARE, ETC. COMPONENTS ARE IN GOOD TO FAIR CONDITION AND GENERALLY SUITED FOR RESTORATION REUSE UNLESS NOTED OTHERWISE.
 - RESTORE EXISTING SILL TO PREVENT OPENING TO EXTERIOR

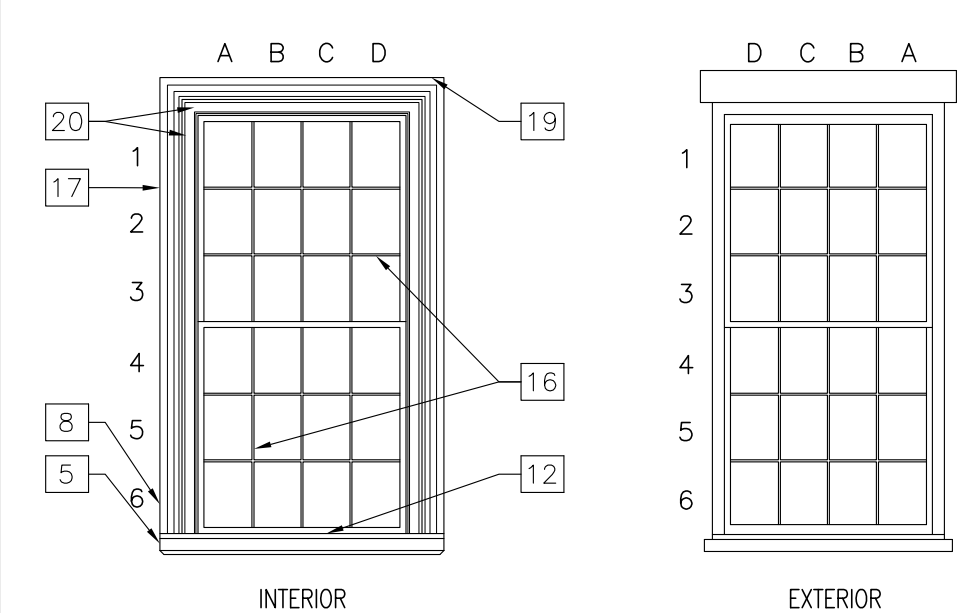
IMAGE_101B

- NOTES
- EXISTING WOOD WINDOW SASH, SILL, CASING, ETC. COMPONENTS ARE IN GOOD TO FAIR CONDITION AND GENERALLY SUITED FOR RESTORATION AND REUSE UNLESS NOTED OTHERWISE
 - INSPECT SILL AND JAMB FOR WATER DAMAGE. CONFIRM CONDITION REPAIR/REPLACE BASED ON CONDITION.

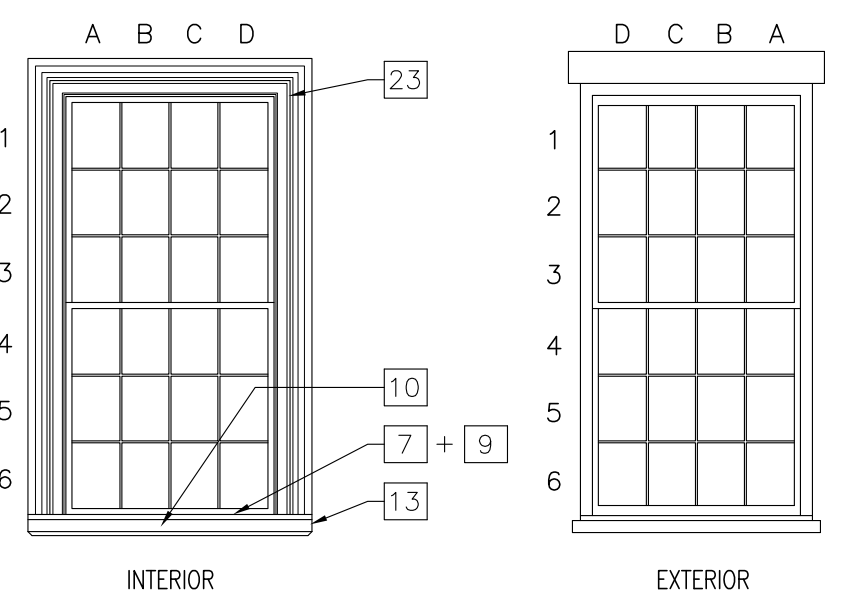
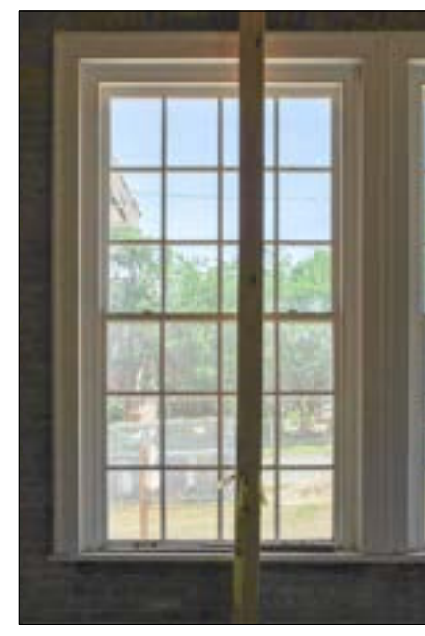
1 WINDOW NO. 106D
ROOM 106

- EXISTING WOOD WINDOW SASH, CASING, ETC. COMPONENTS ARE IN GOOD TO FAIR CONDITION AND GENERALLY SUITED FOR RESTORATION AND REUSE UNLESS NOTED OTHERWISE.
- REPLACE MISSING APRON, UNLESS WAINSCOTING TO BE INSTALLED IN ITS PLACE.
- REPLACE WOOD ROT AT BASE FRAMING (SEE GENERAL NOTES)

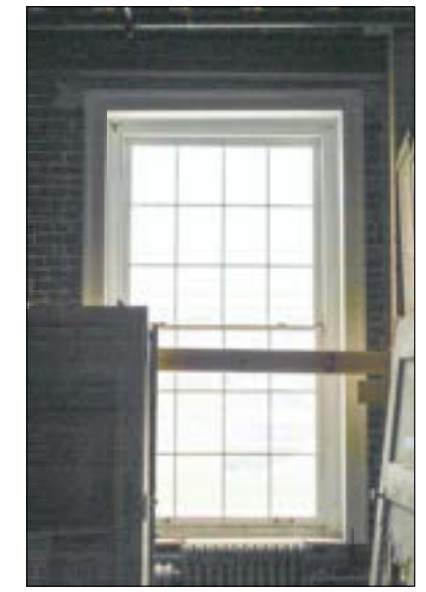
2 WINDOW NO. 107A
ROOM 107

- EXISTING WOOD WINDOW SASH, SILL, CASING, ETC. COMPONENTS ARE IN GOOD TO FAIR CONDITION AND GENERALLY SUITED FOR RESTORATION AND REUSE UNLESS NOTED OTHERWISE.
- REPLACE MISSING APRON, UNLESS WAINSCOTING TO BE INSTALLED IN ITS PLACE.
- REPLACE WOOD ROT AT BASE FRAMING (SEE GENERAL NOTES)
- REPAIR AND FIX HOLES IN RAIL AND STILE AT HEAD

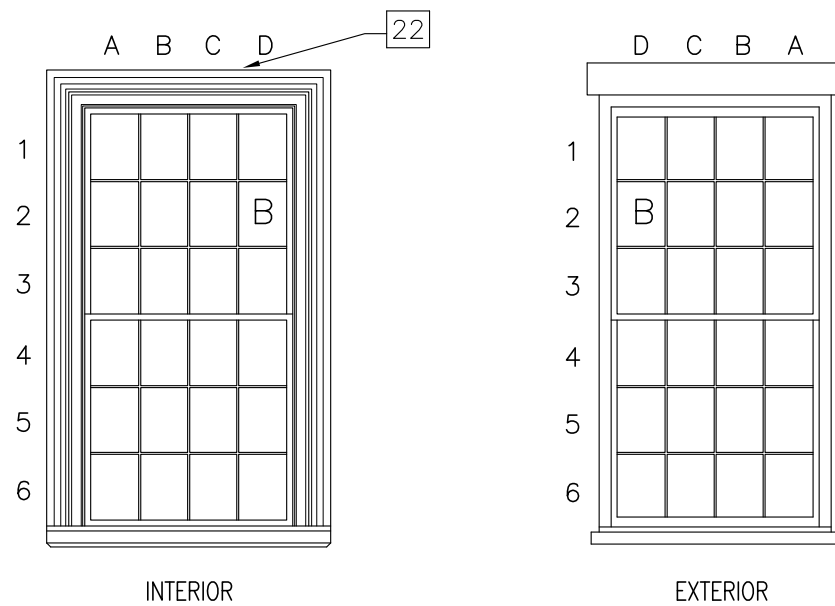
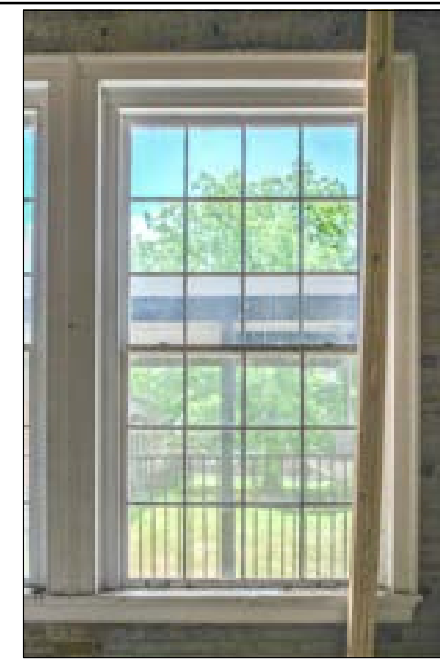
2 WINDOW NO. 116A
ROOM 116

1. EXISTING WOOD WINDOW SASH, SILL, CASING, ETC. COMPONENTS ARE IN GOOD TO FAIR CONDITION AND GENERALLY SUITED FOR RESTORATION AND REUSE UNLESS NOTED OTHERWISE.
2. REPLACE WOOD ROT AT HEADER (SEE GENERAL NOTES)

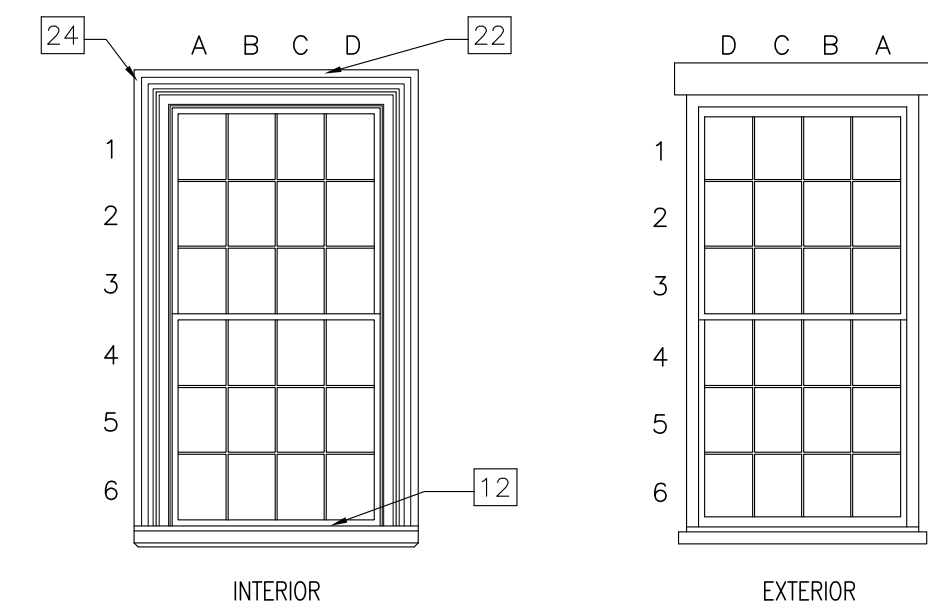
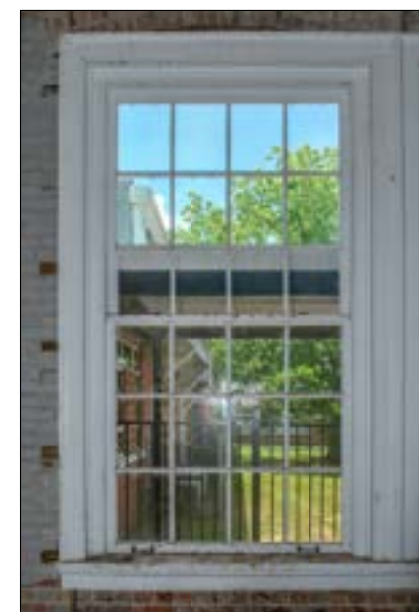
4 WINDOW NO. 116C
ROOM 116

1. EXISTING WOOD WINDOW SASH, SILL, CASING, ETC. COMPONENTS ARE IN GOOD TO FAIR CONDITION AND GENERALLY SUITED FOR RESTORATION AND REUSE UNLESS NOTED OTHERWISE.
2. REPLACE WOOD ROT AT HEADER (SEE GENERAL NOTES)

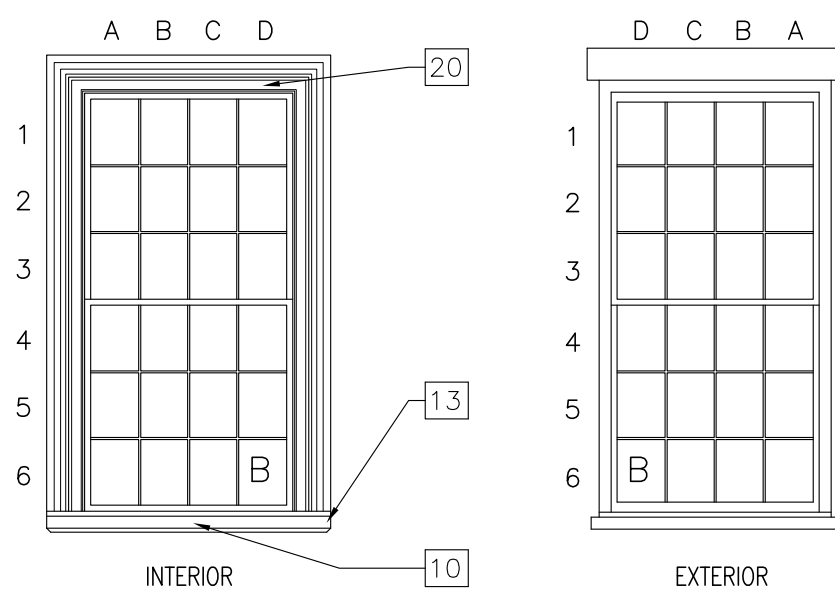
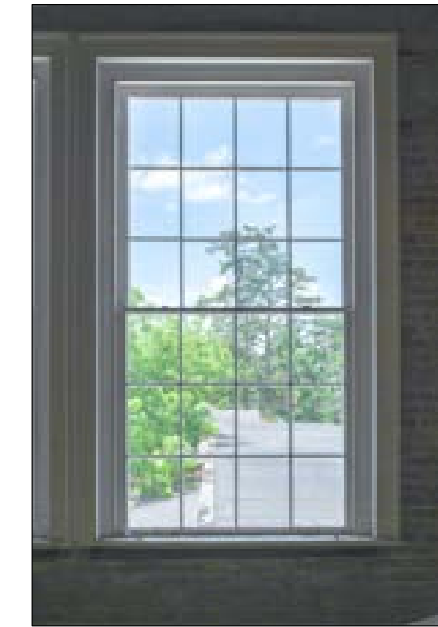
1 WINDOW NO. 201A ROOM 201

- 1. EXISTING WOOD WINDOW SASH, SILL, CASING, ETC. COMPONENTS ARE IN GOOD TO FAIR CONDITION AND GENERALLY SUITED FOR RESTORATION AND REUSE UNLESS NOTED OTHERWISE.
- 2. REPLACE MISSING APRON, UNLESS WAINSCOTING TO BE INSTALLED IN ITS PLACE.
- 3. REPLACE ROTTEN WOOD BASE FRAMING (SEE GENERAL NOTES)

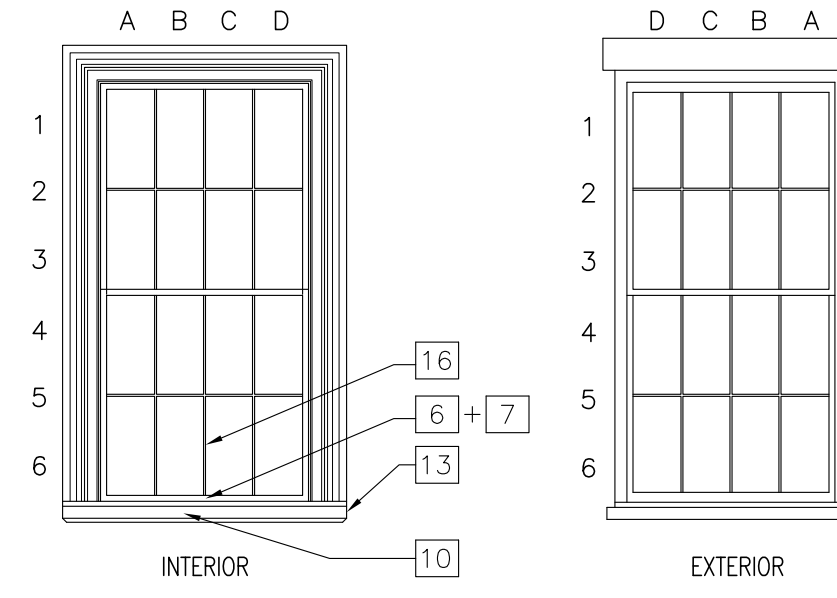
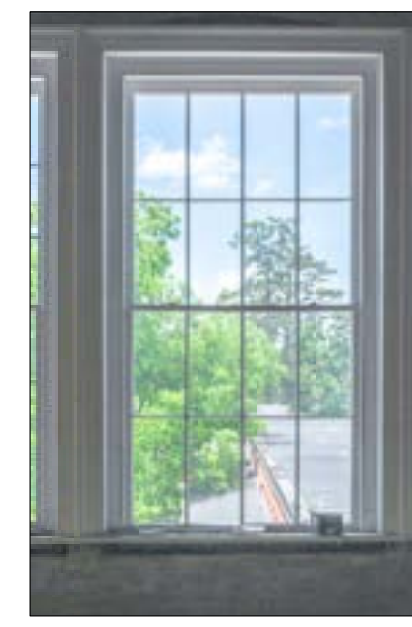
2 WINDOW NO. 201B ROOM 201

- 1. EXISTING WOOD WINDOW SASH, SILL, CASING, ETC. COMPONENTS ARE IN GOOD TO FAIR CONDITION AND GENERALLY SUITED FOR RESTORATION AND REUSE UNLESS NOTED OTHERWISE.
- 2. REPLACE MISSING APRON, UNLESS WAINSCOTING TO BE INSTALLED IN ITS PLACE.
- 3. REPLACE ROTTEN WOOD BASE FRAMING (SEE GENERAL NOTES)

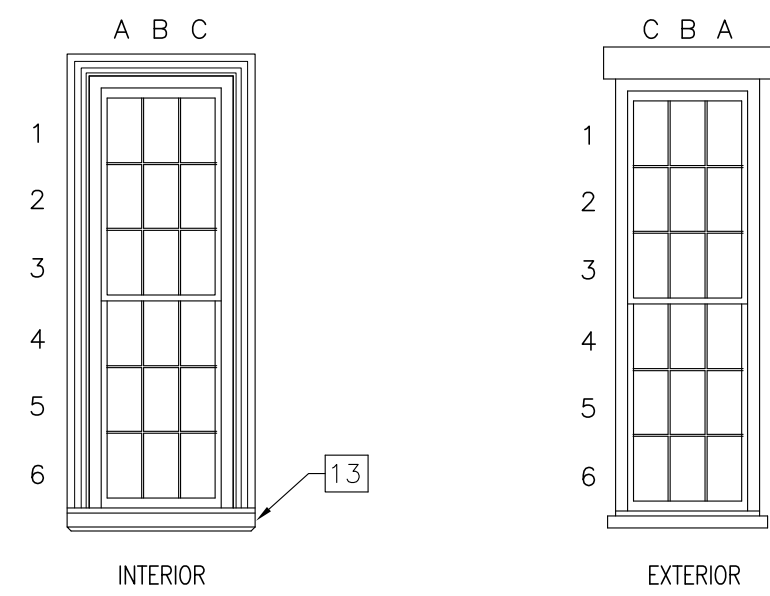
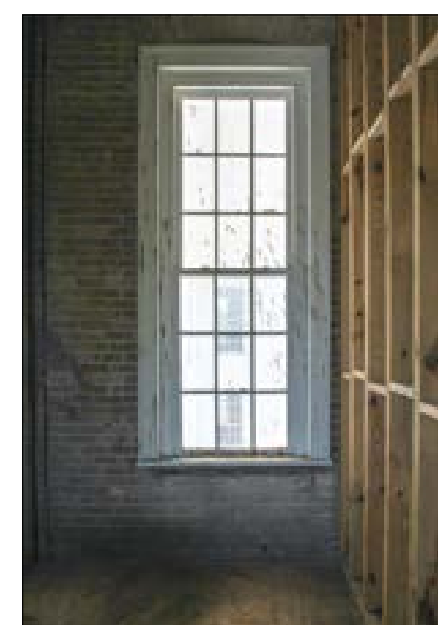
4 WINDOW NO. 205A ROOM 205

- 1. EXISTING WOOD WINDOW SASH, SILL, CASING, ETC. COMPONENTS ARE IN GOOD TO FAIR CONDITION AND GENERALLY SUITED FOR RESTORATION AND REUSE UNLESS NOTED OTHERWISE.
- 2. REPLACE MISSING APRON, UNLESS WAINSCOTING TO BE INSTALLED IN ITS PLACE.

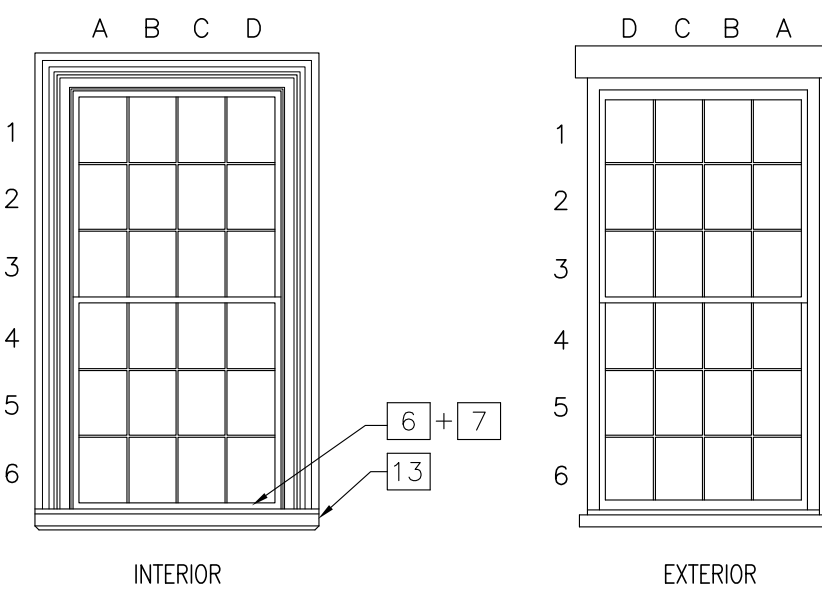
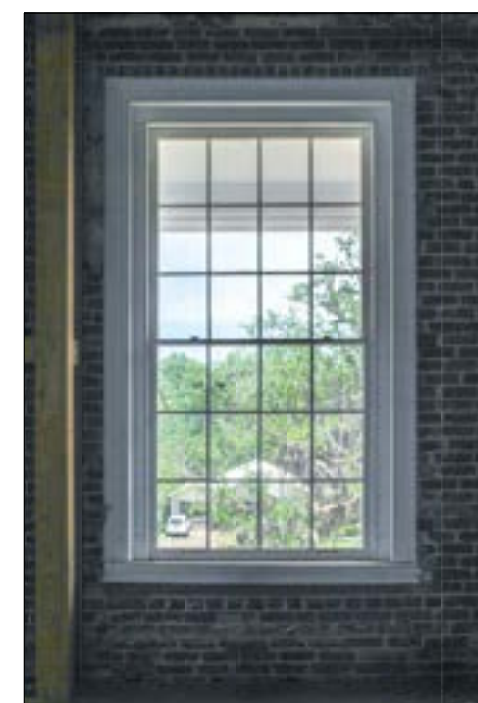
2 WINDOW NO. 207E
ROOM 207

1. EXISTING WOOD WINDOW SASH, SILL, CASING, ETC. COMPONENTS ARE IN GOOD TO FAIR CONDITION AND GENERALLY SUITED FOR RESTORATION AND REUSE UNLESS NOTED OTHERWISE.
2. REPLACE MISSING APRON, UNLESS WAINSCOTING TO BE INSTALLED IN ITS PLACE.

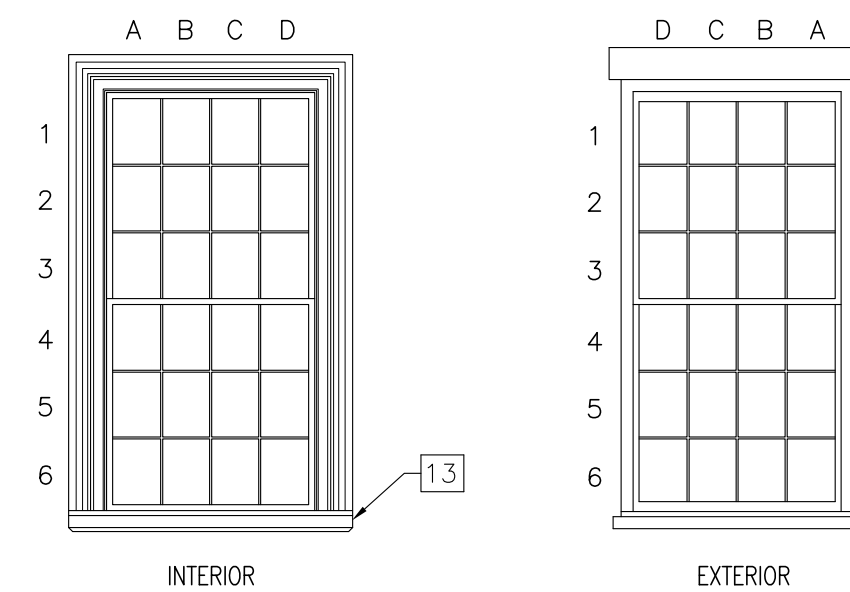
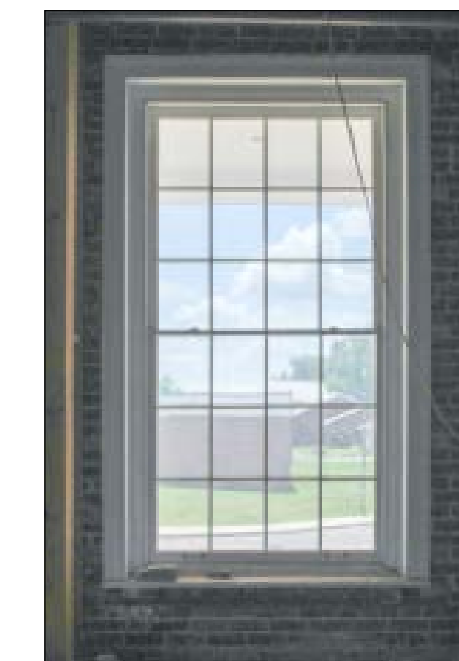
3 WINDOW NO. 207F
ROOM 207

1. EXISTING WOOD WINDOW SASH, SILL, CASING, ETC. COMPONENTS ARE IN GOOD TO FAIR CONDITION AND GENERALLY SUITED FOR RESTORATION AND REUSE UNLESS NOTED OTHERWISE.
2. REPLACE MISSING APRON, UNLESS WAINSCOTING TO BE INSTALLED IN ITS PLACE.
3. MISSING BASE FRAMING, REPLACE TO MATCH EXISTING

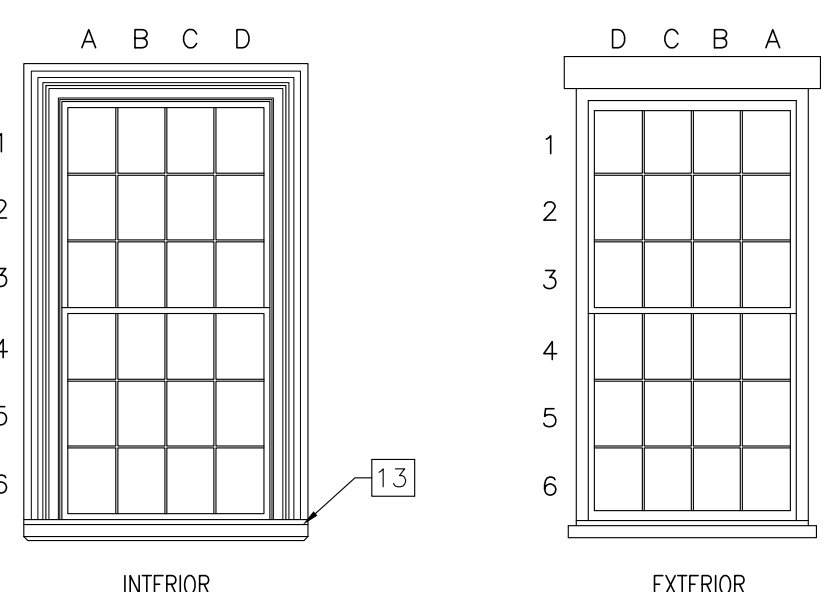
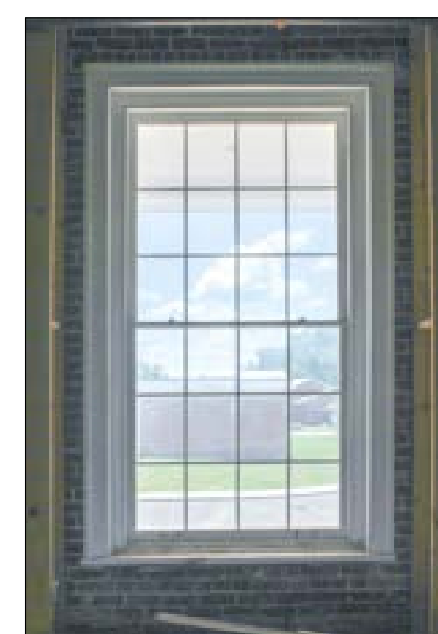
4 WINDOW NO. 207G
ROOM 207

1. EXISTING WOOD WINDOW SASH, SILL, CASING, ETC. COMPONENTS ARE IN GOOD TO FAIR CONDITION AND GENERALLY SUITED FOR RESTORATION AND REUSE UNLESS NOTED OTHERWISE.
2. REPLACE MISSING APRON, UNLESS WAINSCOTING TO BE INSTALLED IN ITS PLACE.

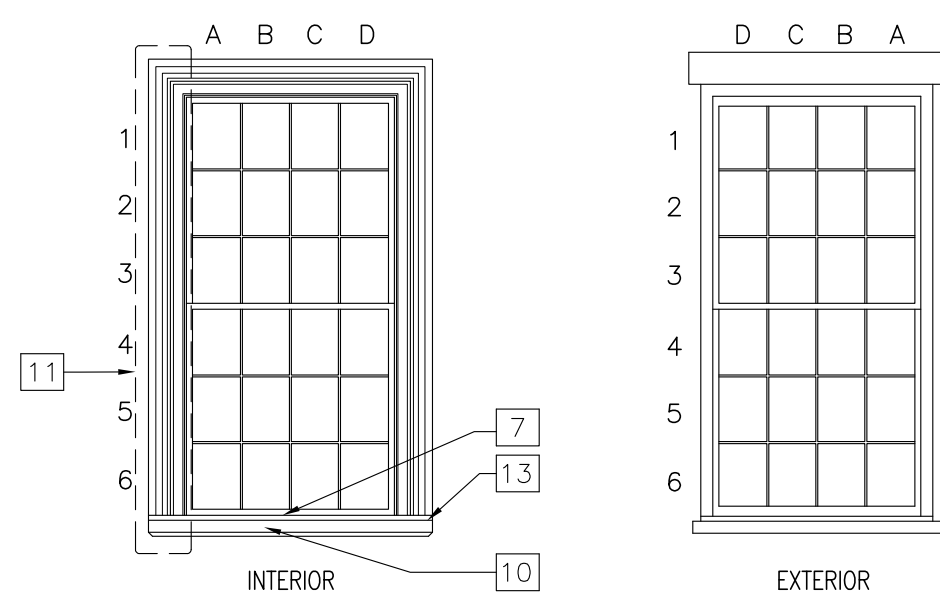
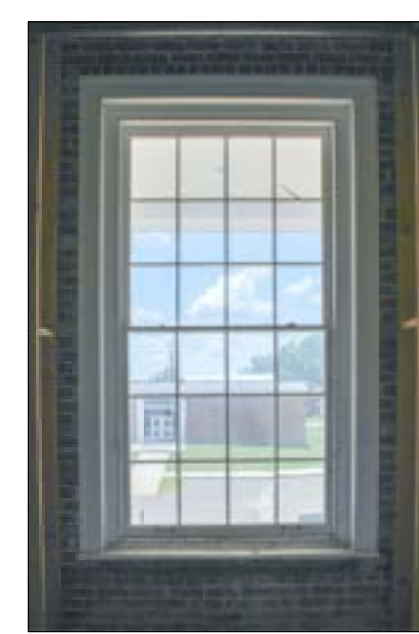
1. EXISTING WOOD WINDOW SASH, CASING, ETC. COMPONENTS ARE IN GOOD TO FAIR CONDITION AND GENERALLY SUITED FOR RESTORATION AND REUSE UNLESS NOTED OTHERWISE.
2. REPLACE MISSING APRON, UNLESS WAINSCOTING TO BE INSTALLED IN ITS PLACE.
3. REPLACE ROTTEN WOOD BASE FRAMING (SEE GENERAL NOTES)

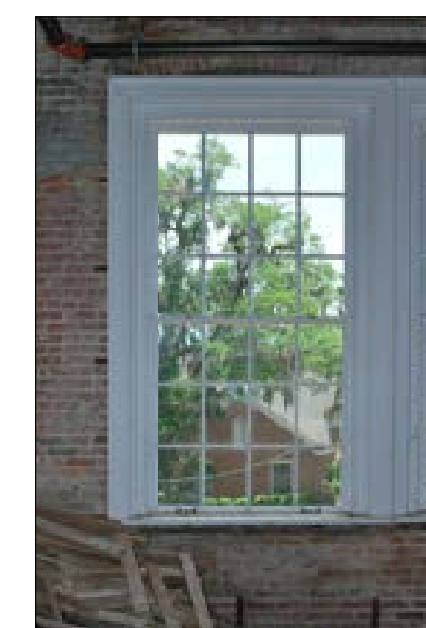
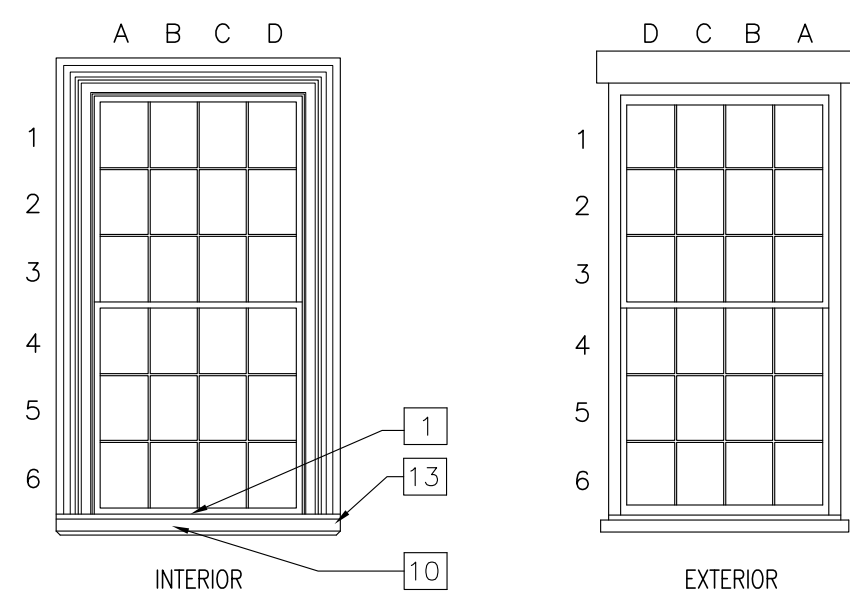
3 WINDOW NO. 208A
ROOM 208

- EXISTING WOOD WINDOW SASH, SILL, CASING, ETC. COMPONENTS ARE IN GOOD TO FAIR CONDITION AND GENERALLY SUITED FOR RESTORATION AND REUSE UNLESS NOTED OTHERWISE.
- REPLACE MISSING APRON, UNLESS WAINSCOTING TO BE INSTALLED IN ITS PLACE.
- REPLACE ROTTEN WOOD BASE FRAMING (SEE GENERAL NOTES)

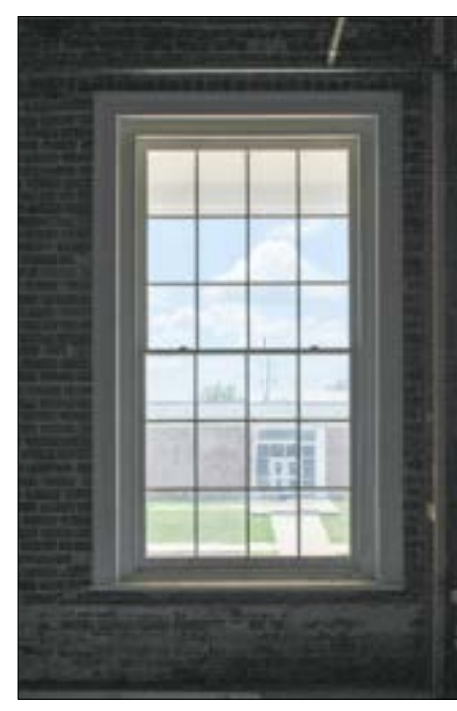
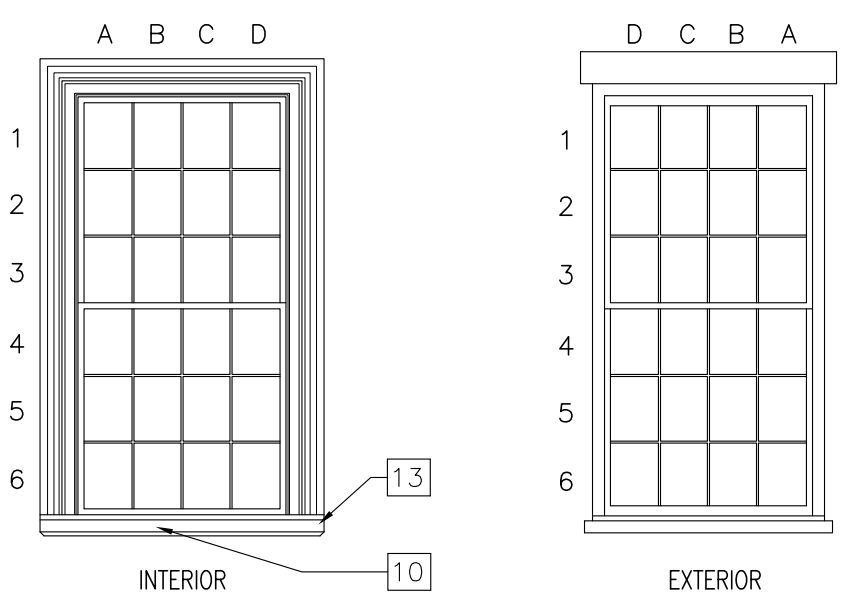
2 WINDOW NO. 207J
ROOM 207

- EXISTING WOOD WINDOW SASH, SILL, CASING, ETC. COMPONENTS ARE IN GOOD TO FAIR CONDITION AND GENERALLY SUITED FOR RESTORATION AND REUSE UNLESS NOTED OTHERWISE.
- REPLACE MISSING APRON, UNLESS WAINSCOTING TO BE INSTALLED IN ITS PLACE.
- MISSING BASE FRAMING, REPLACE TO MATCH EXISTING

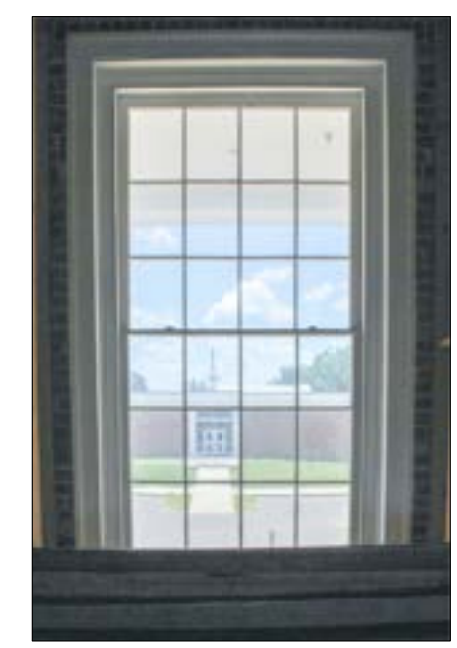
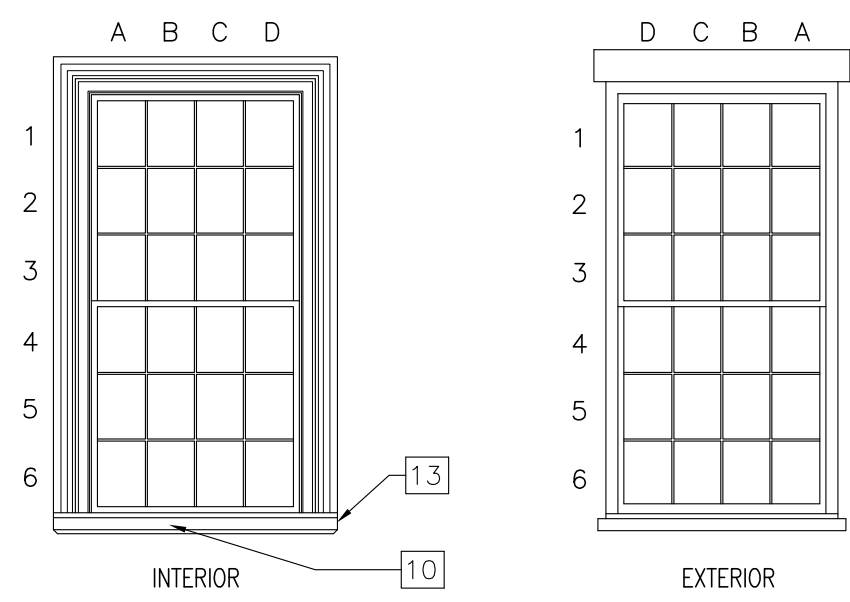
1 WINDOW NO. 207I
ROOM 207

- EXISTING WOOD WINDOW SASH, SILL, CASING, ETC. COMPONENTS ARE IN GOOD TO FAIR CONDITION AND GENERALLY SUITED FOR RESTORATION AND REUSE UNLESS NOTED OTHERWISE.
- REPLACE MISSING APRON, UNLESS WAINSCOTING TO BE INSTALLED IN ITS PLACE.
- MISSING BASE FRAMING, REPLACE TO MATCH EXISTING

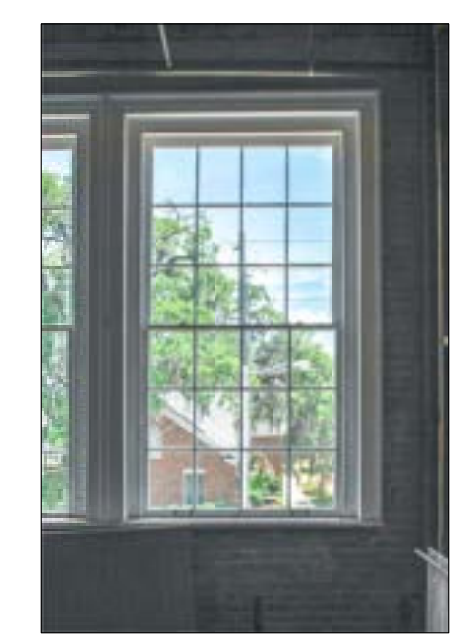
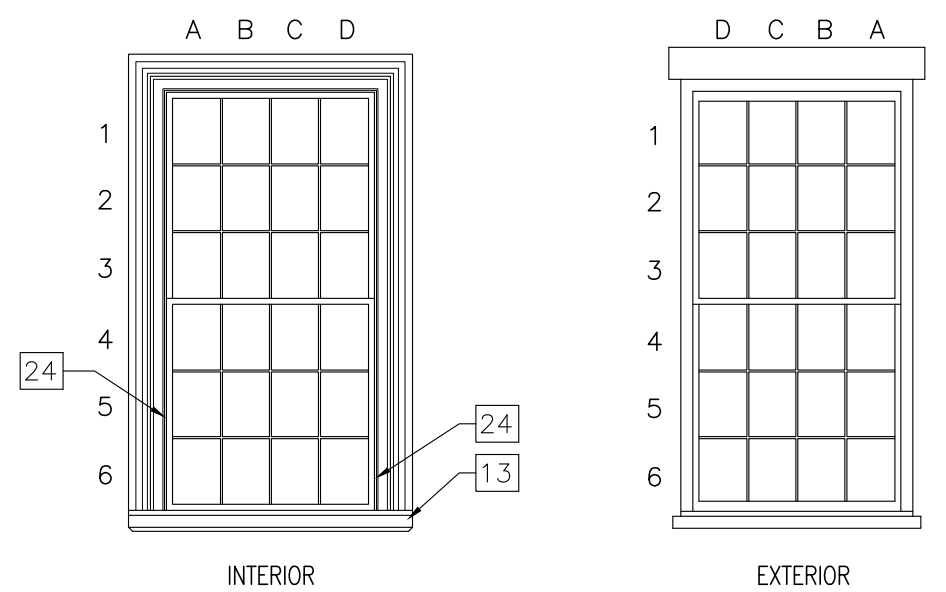
5 WINDOW NO. 208C
ROOM 208

- EXISTING WOOD WINDOW SASH, SILL, CASING, ETC. COMPONENTS ARE IN GOOD TO FAIR CONDITION AND GENERALLY SUITED FOR RESTORATION AND REUSE UNLESS NOTED OTHERWISE.
- REPLACE MISSING APRON, UNLESS WAINSCOTING TO BE INSTALLED IN ITS PLACE.

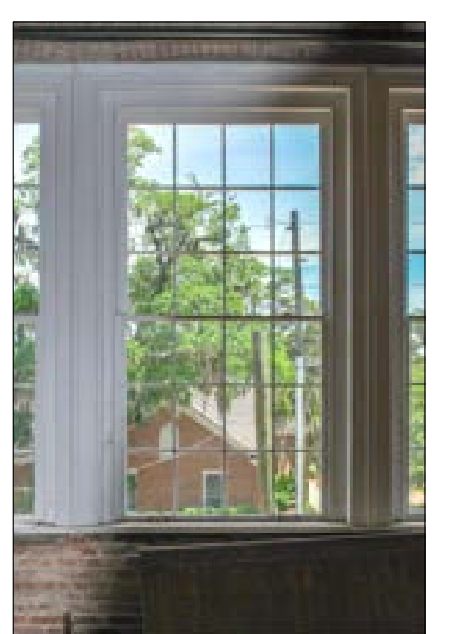
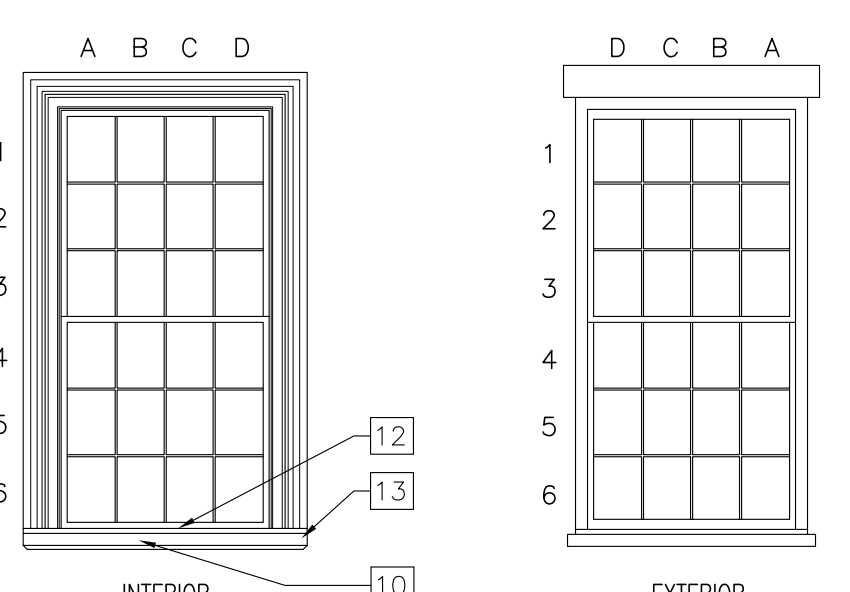
- EXISTING WOOD WINDOW SASH, SILL, CASING, ETC. COMPONENTS ARE IN GOOD TO FAIR CONDITION AND GENERALLY SUITED FOR RESTORATION AND REUSE UNLESS NOTED OTHERWISE.
- REPLACE MISSING APRON, UNLESS WAINSCOTING TO BE INSTALLED IN ITS PLACE.
- REPLACE ROTTEN WOOD BASE FRAMING (SEE GENERAL NOTES)

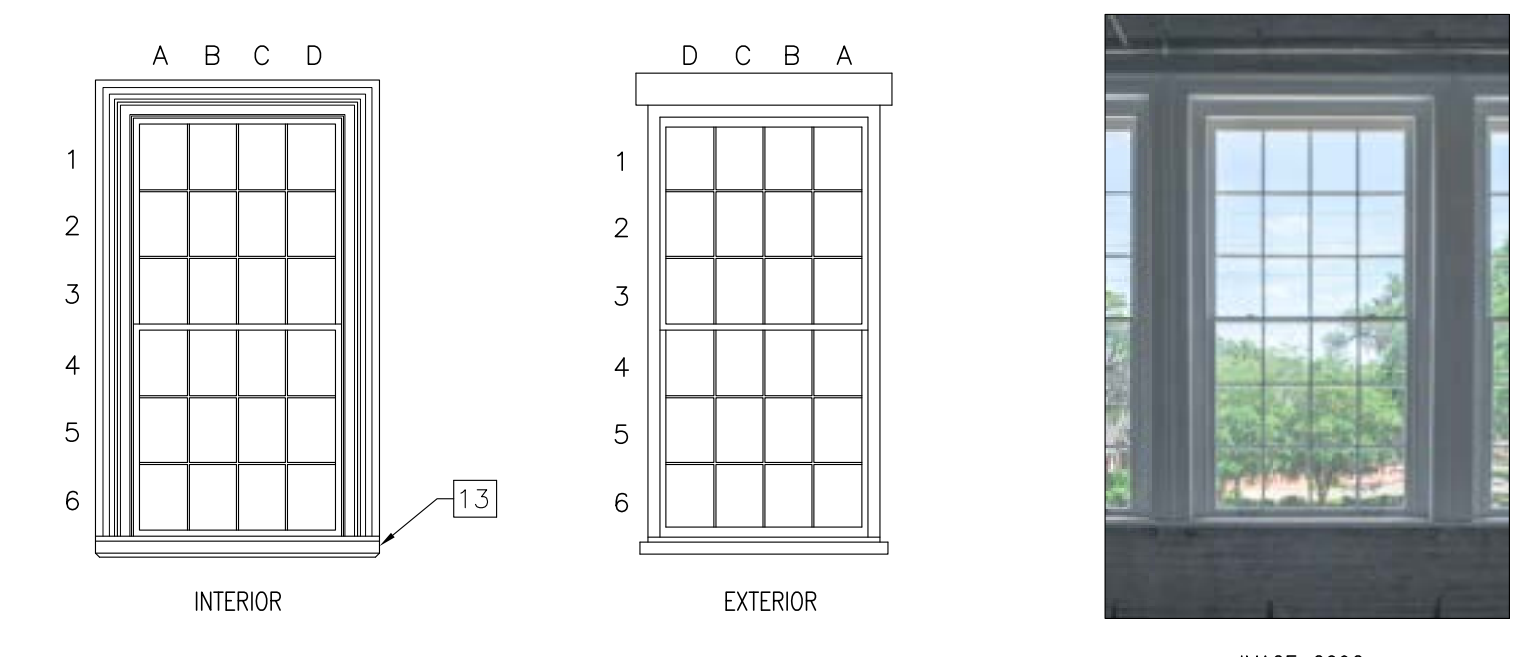
WINDOW NO. 209C
ROOM 209

NOTES
1. EXISTING WOOD WINDOW SASH, SILL, CASING, ETC. COMPONENTS ARE IN GOOD TO FAIR CONDITION AND GENERALLY SUITED FOR RESTORATION AND REUSE UNLESS NOTED OTHERWISE.
2. REPLACE MISSING APRON, UNLESS WAINSCOTING TO BE INSTALLED IN ITS PLACE.

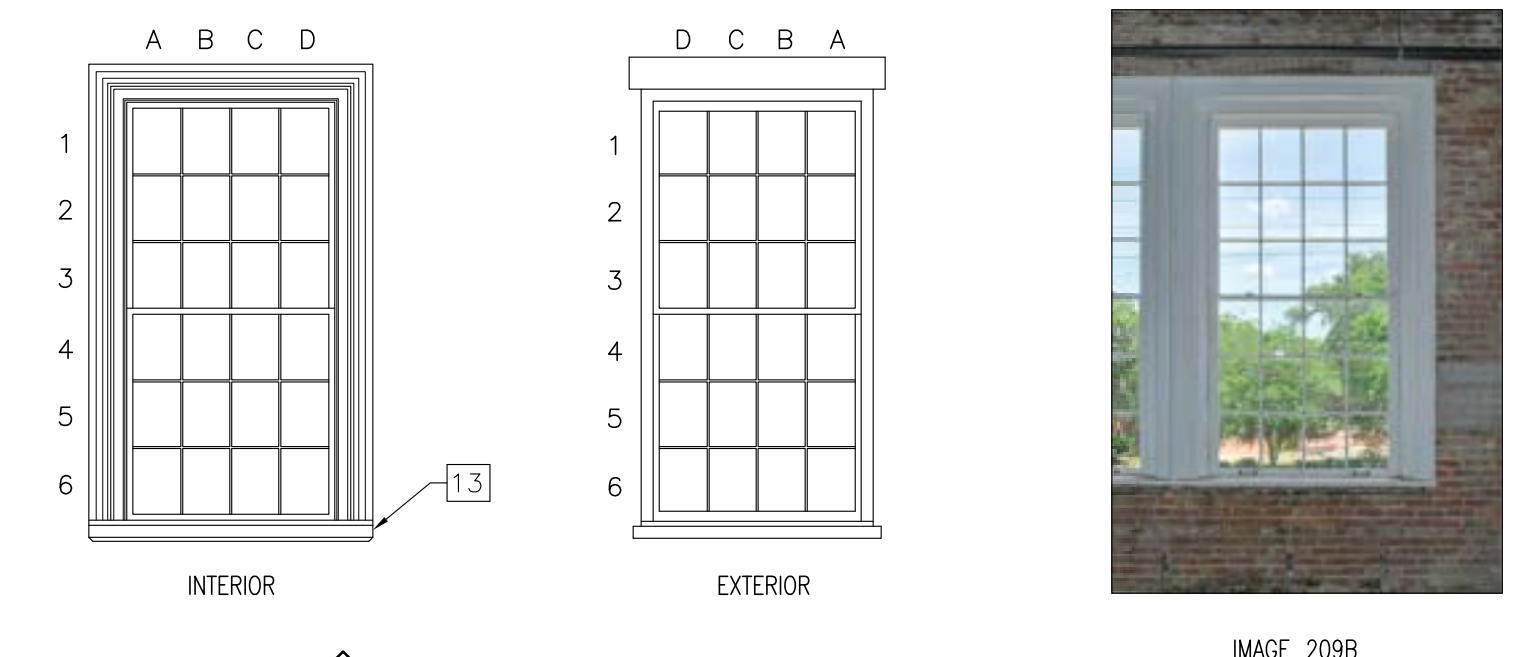
WINDOW NO. 209B
ROOM 209

NOTES
1. EXISTING WOOD WINDOW SASH, SILL, CASING, ETC. COMPONENTS ARE IN GOOD TO FAIR CONDITION AND GENERALLY SUITED FOR RESTORATION AND REUSE UNLESS NOTED OTHERWISE.
2. REPLACE MISSING APRON, UNLESS WAINSCOTING TO BE INSTALLED IN ITS PLACE.

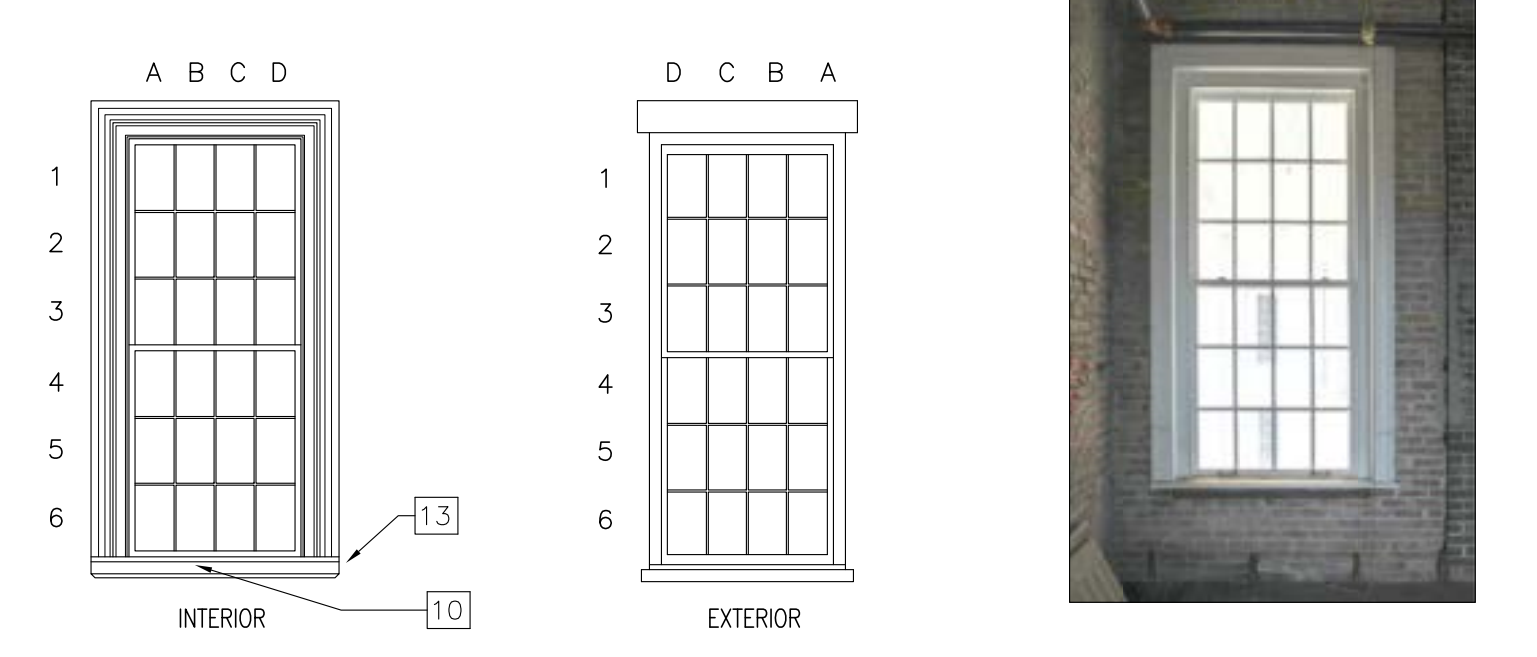
WINDOW NO. 209A
ROOM 209

NOTES
1. EXISTING WOOD WINDOW SASH, SILL, CASING, ETC. COMPONENTS ARE IN GOOD TO FAIR CONDITION AND GENERALLY SUITED FOR RESTORATION AND REUSE UNLESS NOTED OTHERWISE.
2. REPLACE MISSING APRON, UNLESS WAINSCOTING TO BE INSTALLED IN ITS PLACE.
3. REPLACE ROTTEN WOOD BASE FRAMING (SEE GENERAL NOTES)
4. REPAIR AND FIX HOLES IN RAIL AND STILE AT HEAD

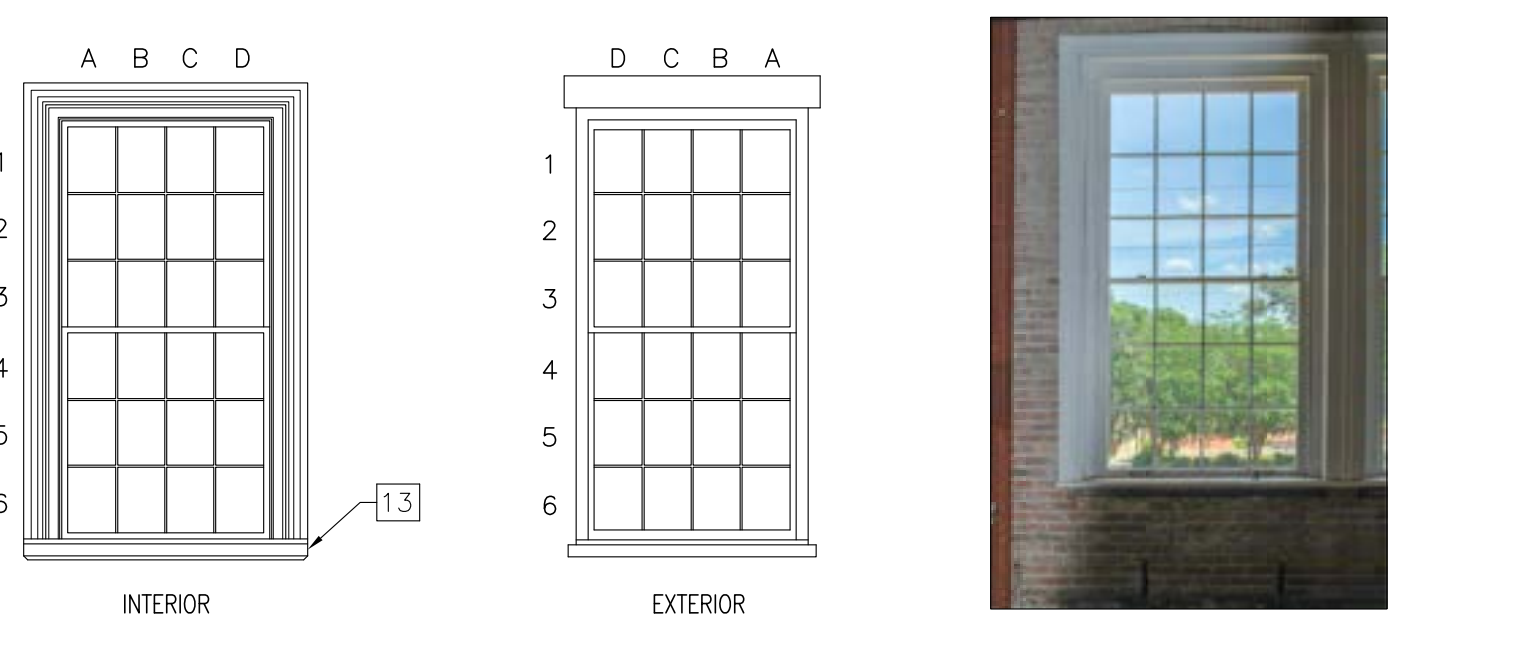
WINDOW NO. 209D
ROOM 209

NOTES
1. EXISTING WOOD WINDOW SASH, SILL, CASING, ETC. COMPONENTS ARE IN GOOD TO FAIR CONDITION AND GENERALLY SUITED FOR RESTORATION AND REUSE UNLESS NOTED OTHERWISE.
2. REPLACE MISSING APRON, UNLESS WAINSCOTING TO BE INSTALLED IN ITS PLACE.
3. MISSING SHIM AT BASE FRAMING, REPLACE TO MATCH EXISTING

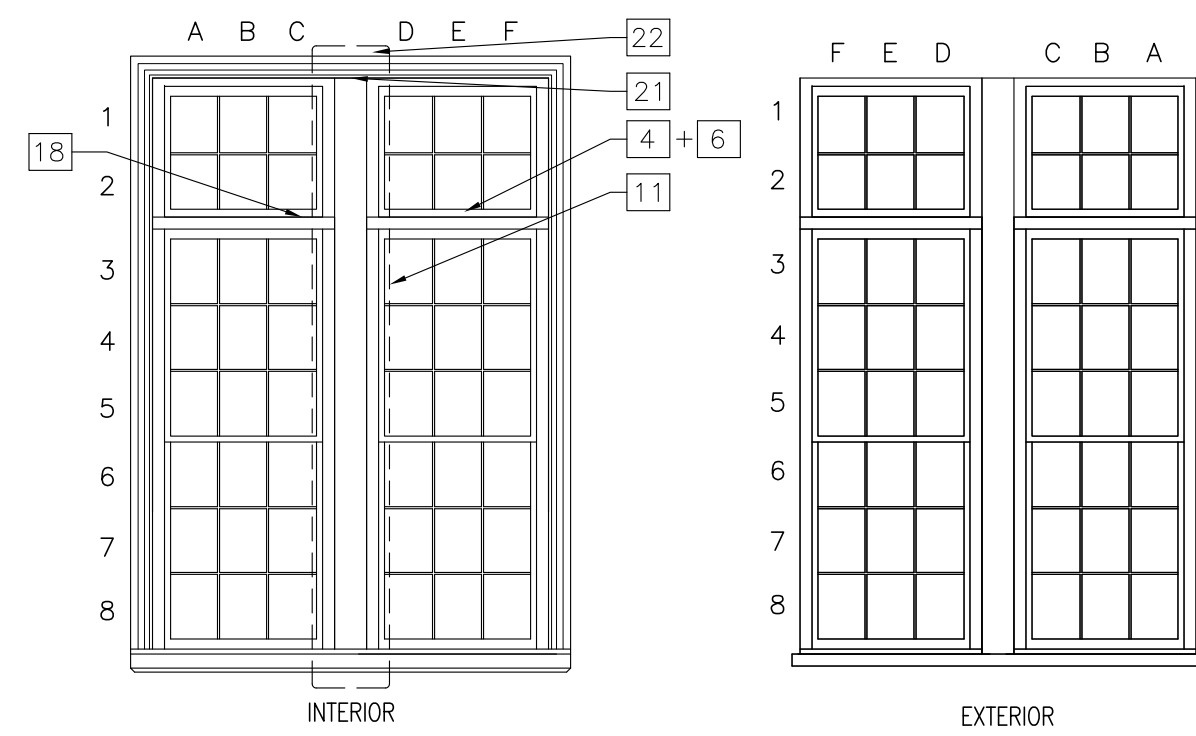
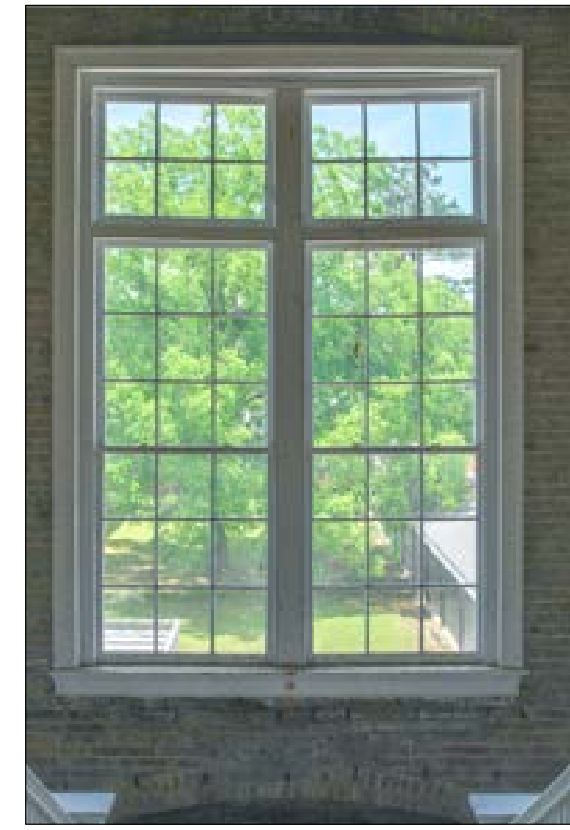
① WINDOW NO. ST 201A
ROOM 209

- EXISTING WOOD WINDOW SASH, SILL, CASING, ETC. COMPONENTS ARE IN GOOD TO FAIR CONDITION AND GENERALLY SUITED FOR RESTORATION AND REUSE UNLESS NOTED OTHERWISE.
- REMOVE AND DISPOSE OF VINES.
- WINDOW CAVING IN THE CENTER, SUSPECTED WOOD ROT. CONTRACTOR TO INVESTIGATE AND REPAIR DAMAGED AREAS TO RESTORE WINDOW TO ITS 1910-1915 CONDITION.
